Introduction

Fretting Corrosion on Galvanized Sheet

Copyright © 2009 – IZA

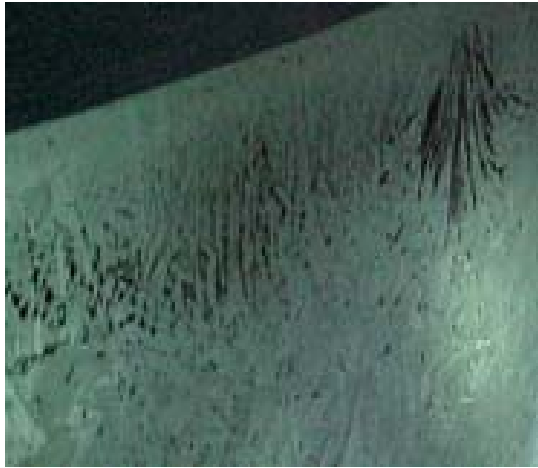
Figures 1 and 2 illustrate the appearance of fretting on galvanized surfaces. In this case the marks are near the edge of the sheet and were reported to have mirror images on the opposite surface.^{vii} Figure 2 is a close-up of the mark on the right hand side of Figure 1.

Figure 1 Fretting near coil edge

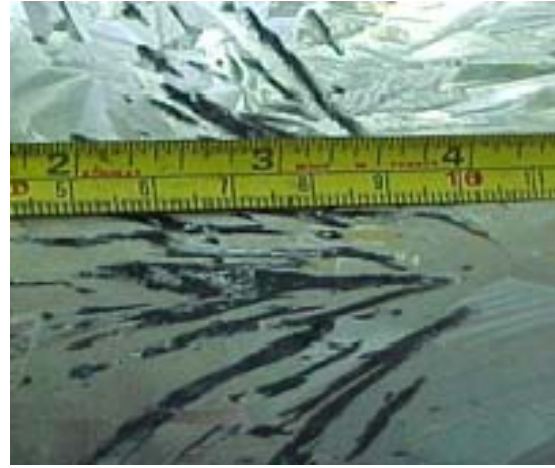
Figure 2 Close-up of right side of Figure 1

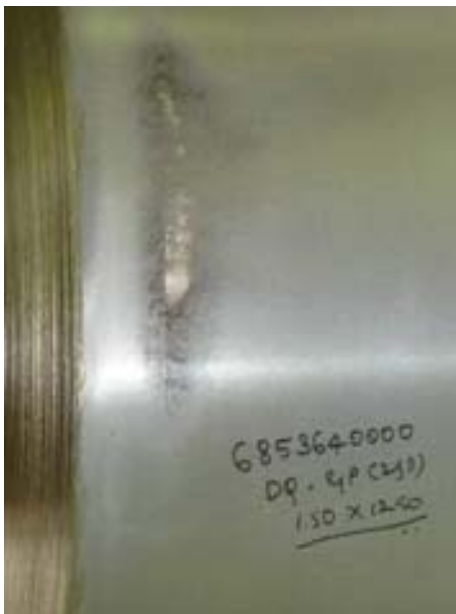
Another observation made about the nature of these marks, in the case of coil-form material shown in Figures 3 and 4, is that they are located exclusively in the area of contact of the saddle support that cradled the coil(s). The coils had been shipped with their eyes horizontal and aligned perpendicular to the direction of movement.

Figure 3 Fretting in area of contact

The second factor that contributes to transit abrasion is load on the surfaces. The black marks are rarely over the entire surface area of a sheet, but are concentrated in specific regions, that have been noted in some cases, e.g., Figs 3 & 4, to be the point(s) that bear the weight of the entire coil or bundle, and perhaps the additional load of product stacked on top. These bearing points are where the most pressure would result on any surface asperities, and is where fretting would begin if relative motion between surfaces does occur.

All of the above measures are not practical in the case of galvanized sheet, but investigations at one steel supplier^{xi} have indicated that some are effective to varying degrees. An action that is very effective is redesigning support saddles to reduce concentrated point loading on the bottom of coils. By distributing the weight of the coil over the entire area of the saddle(s), there is less pressure at any one point, resulting in less transit damage given that vibration will always be present. A slightly less effective way of accomplishing the same result is to reduce the coil size, but this is perhaps not a desirable option for all situations. With either of these actions, care should be taken to avoid stacking coils during transit, as material on the bottom could become overloaded, even with well-designed saddles under them.

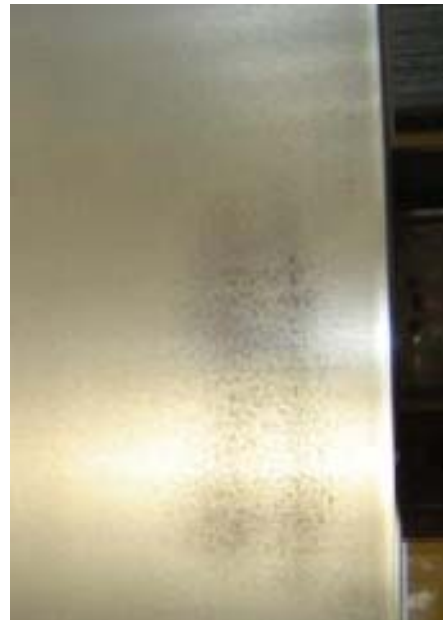
Figure 4 Fretting in area of contact

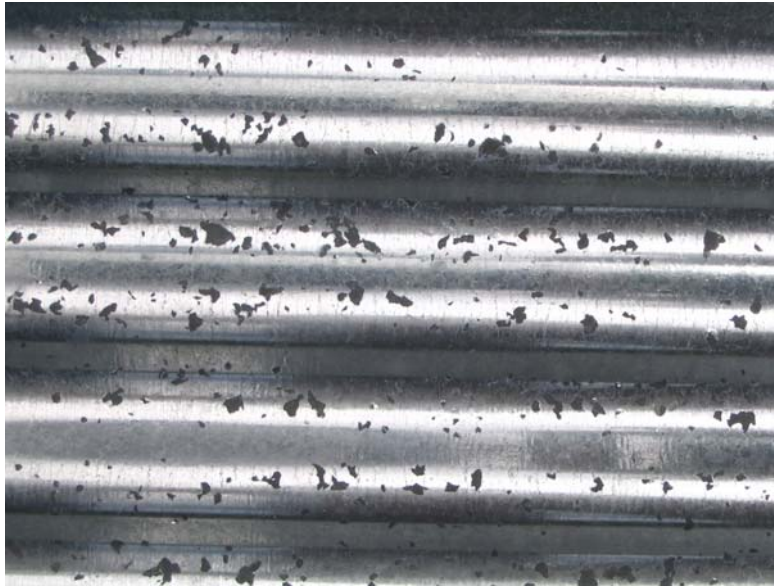
Figure 5 is fretting on corrugated galvanized sheet that was observed after transport to a jobsite from a roll-forming mill.

Figure 5 Transit Abrasion (fretting) on corrugated galvanized sheet

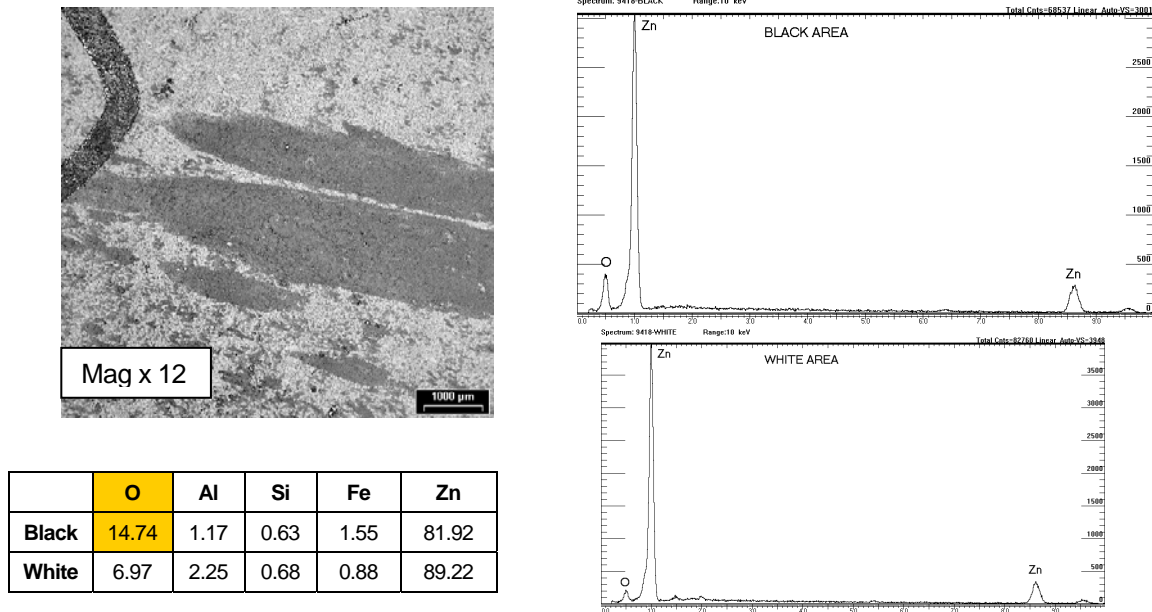
The reason the marks on galvanize are black is believed to come from the nature of the extremely small zinc oxide particles (wear debris) that are the likely result of small amplitude vibration. Zinc oxide that is formed from corrosion of zinc in the atmosphere, or manufactured intentionally for industrial use, is a white powder. Black transit abrasion marks on galvanized surfaces have been shown to be zinc combined with a higher percentage of oxygen than is the case with the metallic zinc on the rest of the surface (see Figure 6)^{viii}, indicating a different form of zinc oxide. It is theorized that this oxide is black, either because of different optical properties than zinc oxide that appears white, or the manner in which the very fine oxide particles are bonded to the surface of the underlying zinc.

Figure 6 Analysis indicating black area has at least twice the oxygen content of the normal white zinc
