# Durability of Galvanized Steel Framing in Residential Buildings

Summary of a ten year report produced by NAHB Research Center, a subsidiary of the National Association of Home Builders (NAHB) in the US and sponsored by International Zinc Association

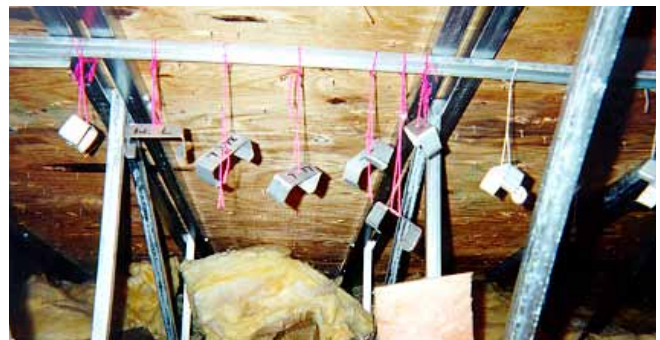
Sample colonies were located in both the attic (see Figure 3) and an exterior wall. The attic colony samples were suspended from the roof framing. The attic was vented by soffit vents on the east and west sides of the house. The wall cavity colony had a west-facing exposure, and contained samples which were accessible for retrieval through access panels. The samples were embedded into the fiberglass batt insulation in the wall cavity.

Figure 3 - Attic Specimens in Miami, Florida Site

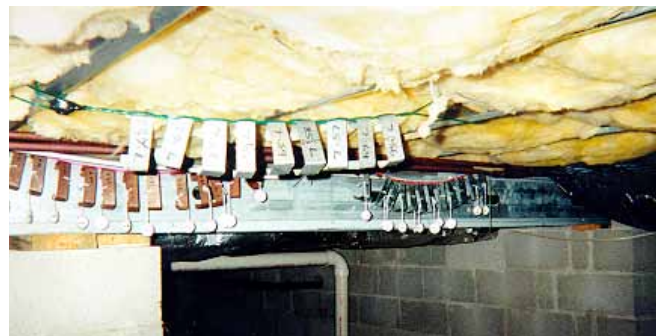
Specimens were installed in the attic, an exterior wall, the crawl space, and under the outdoor deck. The crawlspace contained a set of suspended samples fully exposed to the ambient crawlspace environment, including bare (stripped) stud-type specimens. The bare samples displayed extensive corrosion after just two months of exposure, indicating the aggressive environment in the crawlspace (see Figure 5). Specimens were also installed under an outdoor deck, which represented

Figure 5 - Stud specimens in Leonardtown Site crawlspace. Note the uncoated C-sections in the background show red rust after just two months of exposure.

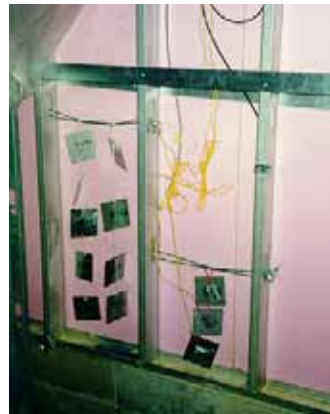
thermistors were attached to one plate of each coating type to record the metal surface temperatures. The attic ambient temperature and relative humidity were also measured and a time of wetness sensor was mounted to a galvanized specimen to record the percentage of time that a moisture film was present. A similar installation was made in the exterior wall colony.

Figure 7 - Wall Cavity Specimens and Sensors in Hamilton, Ontario, Site
