International Zinc Association

Continuous Galvanized Steel Sheet

Corrosion Library

Selected Corrosion Issues Received by the GalvInfo Center as of:

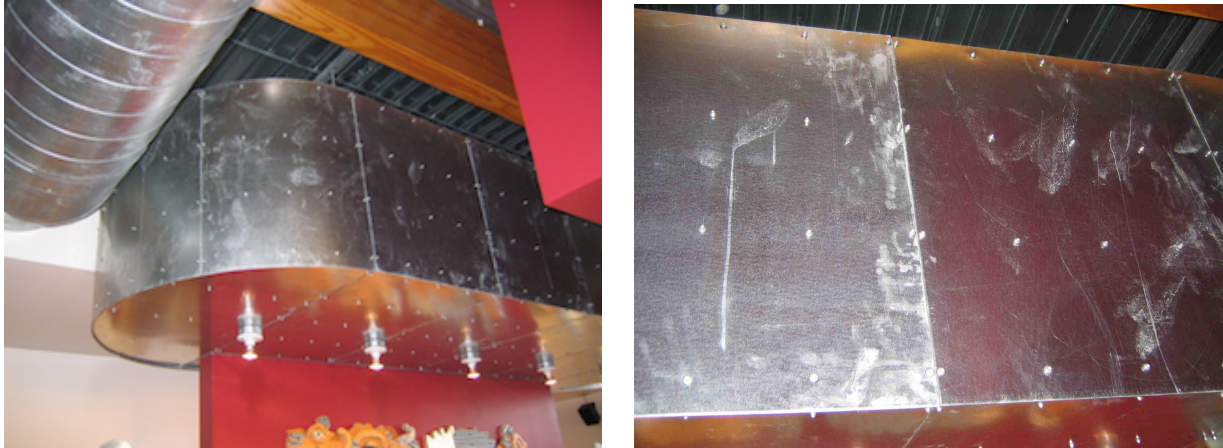
1.1 Fingerprinting

Fingerprinting on galvanized HVAC assembly (October 2004)

Perspiration from workers can dissolve Cr^{+6} in the passivation film, after which the salt corrodes the zinc. Stains are not entirely removable. Application of phosphoric acid may even out appearance but will dull the entire surface. An oxalic acid cleaner, "Bar Keepers Friend" is reported to be able to almost remove these stains.

Prevention: Use acrylic coated galvanize "Plus", or workers should wear gloves and long sleeves.

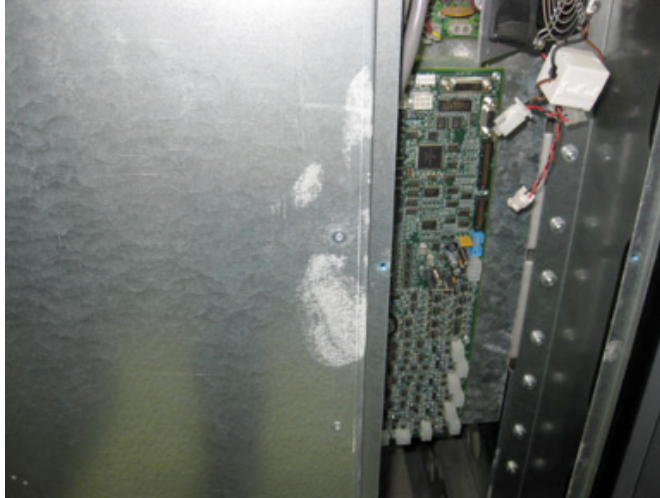
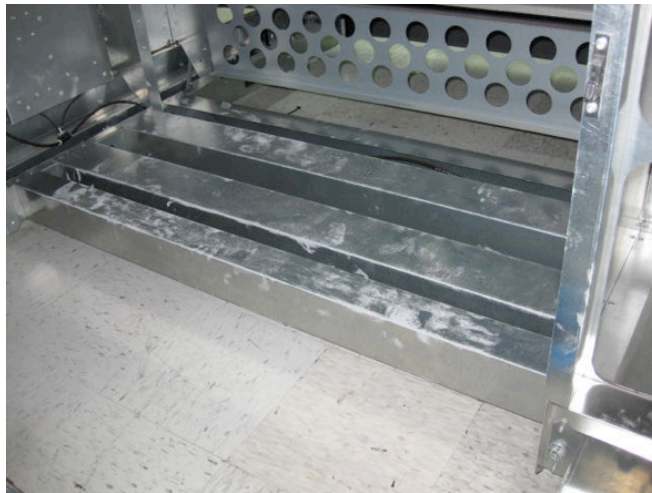
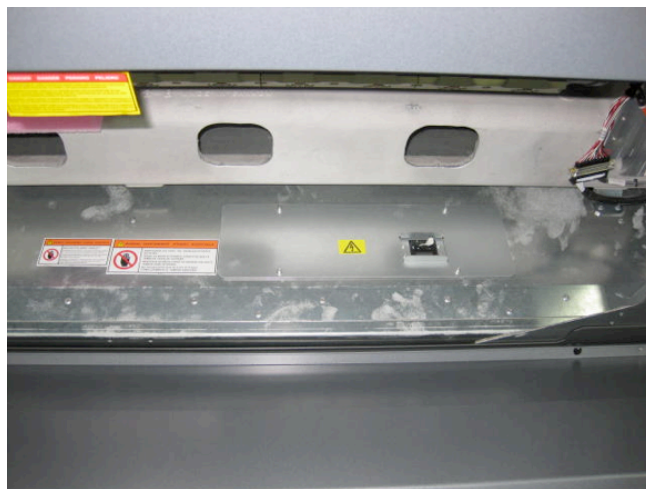
Fingerprinting on galvanized electronic equipment panels (November 2009)

Corrosion was seen on galvanized electronic equipment panels/frames after ocean vessel shipment from Asia. The initial concern was that water damage occurred in transit. The above

photos of the condition, however, have all the appearances of fingerprinting that most likely occurred during assembly and/or handling of the equipment.

Prevention: Use acrylic coated galvanize "Plus", or workers should wear gloves and long sleeves.

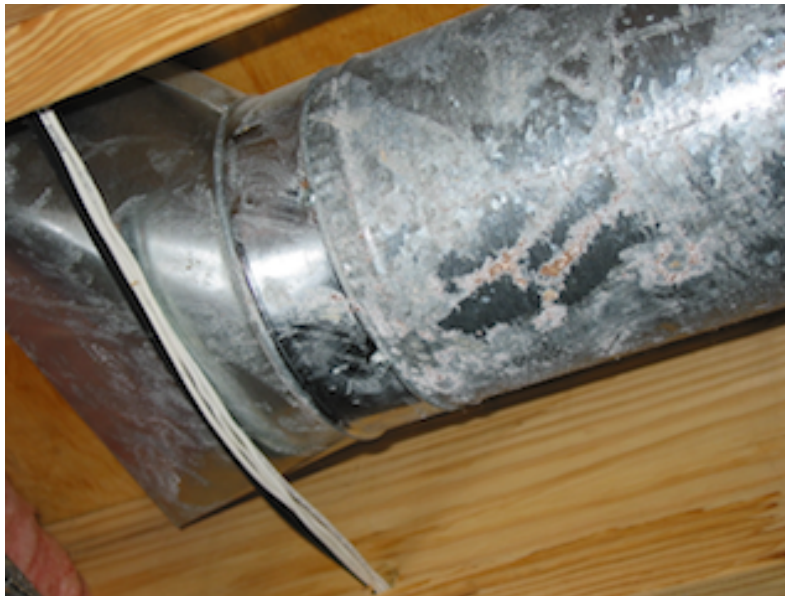
1.2 HVAC Ductwork Corrosion

Corroded residential ductwork (March 2005)

The galvanized ductwork in the entire basement of a private home mysteriously corroded to the point of red rust in some locations. As the photo below shows, it was attacked by an aggressive substance. Apparently, there was a small roof leak that entered one register, but the extent and severity of the damage is inconsistent with plain water coming in contact with the ductwork. One possibility is that the leaking water dissolved aggressive chemicals from the wood in the house before it reached the zinc.

Prevention: Avoid water getting into ventilation ducts, as much as that is possible.

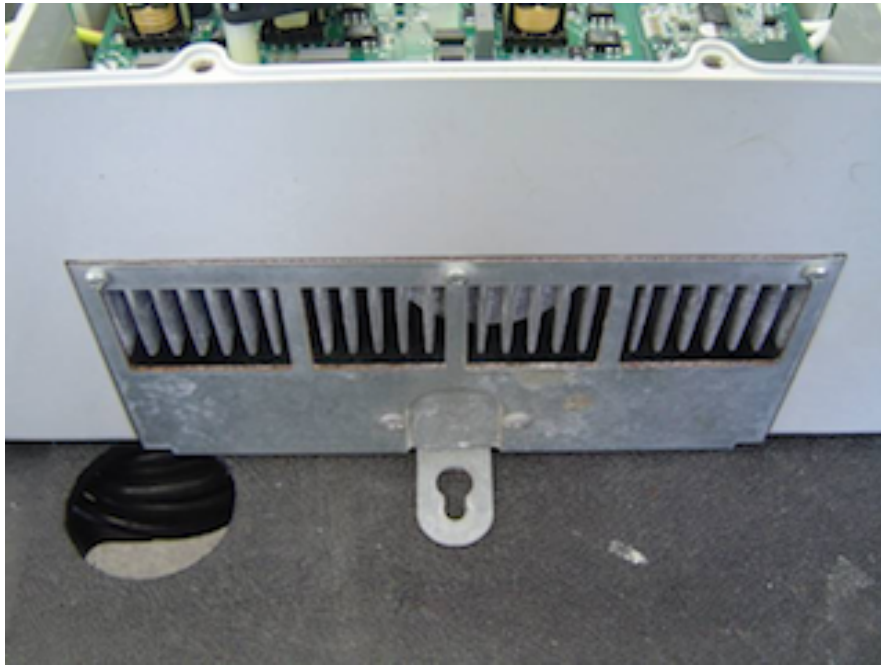
1.3 Cut Edge Corrosion

Cosmetic rust on the sheared edges of 0.080" G90 in a greenhouse environment
(March 2009)

The concern was the rust on the shear-cut edge, and would a heavier coating prevent it. In such an environment, edge rust would always occur on sheet as thick as this, but it would not progress beyond the extent in the above photo until the nearby zinc was consumed. A thicker zinc coating would delay this.

Prevention: To completely prevent edge rust, post HD galvanizing would be necessary. Painting the edges with zinc-rich paint would delay it significantly.

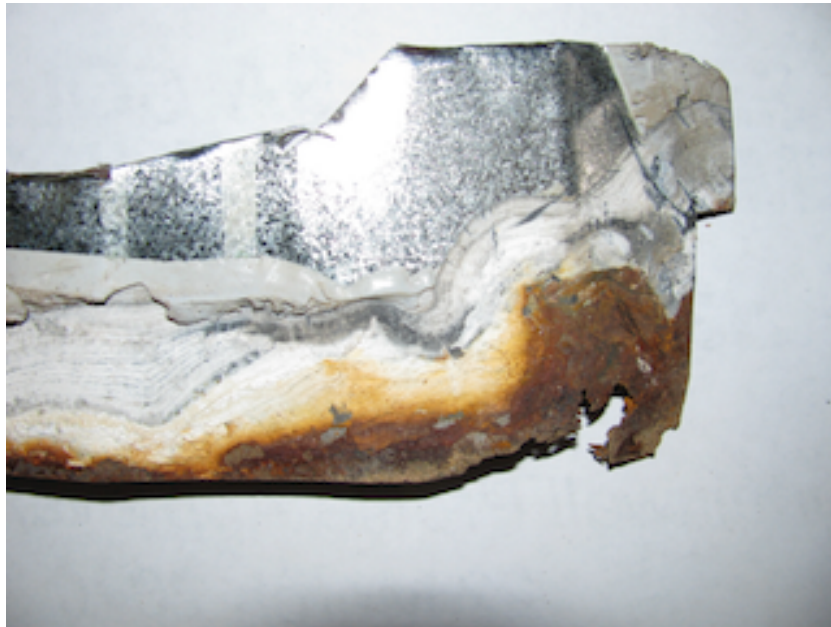
1.4 Corrosion Due to Soil – Case 1

Corrosion on galvanized flashing close to the ground on a stucco wall (April 2010)

A corrosion problem encountered on G90 flashing at the bottom of stucco walls in resort buildings in California. Corrosion is proceeding from bottom up. “Beach marks” in white corrosion product indicate cyclic attacks, similar to fatigue crack failure. It is likely related to soil chemistry and repeated wetting events from both irrigation and rain.

Prevention: Soil near the base of a wall should be covered with stones, or paved over to prevent it splashing on the flashing during irrigation or rainfall.

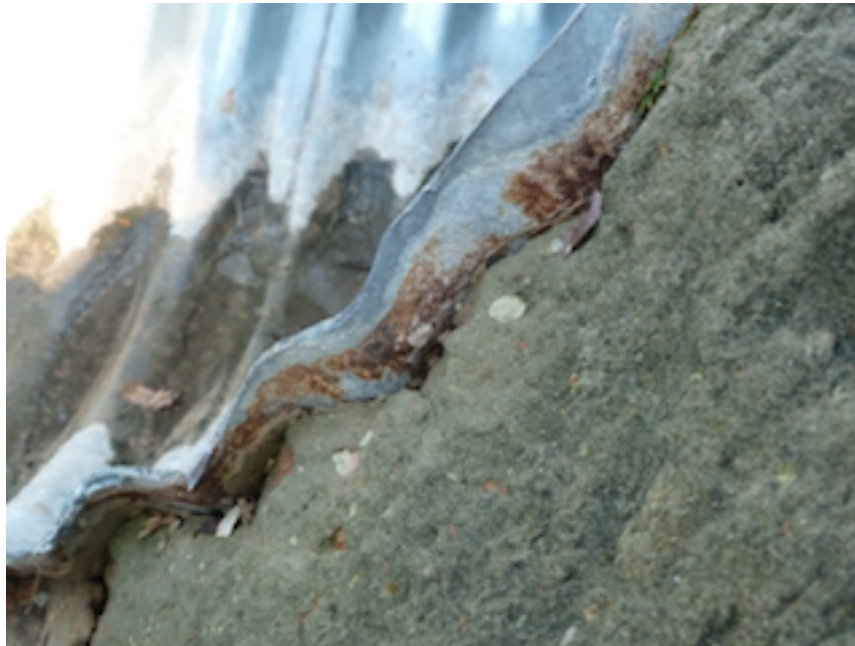
1.5 Corrosion Due to Soil – Case 2

Soil-side corrosion on culvert pipe (January 2012)

Soil-side corrosion in culvert pipe after 3 years. The pipe was laid in cement-stabilized sand and the corrosion revealed itself after a flood that washed some of the sand back from the end. The environment against the outside of the pipe must have been constantly wet to get such a degree of corrosion in such a short time. It may just be a condition close to the end of pipe due to dripping.

Prevention: *Unknown. Due to the myriad types of soil conditions that exist, viz., widely varying chloride and moisture contents, and pH levels, the solution to corrosion issues of galvanized sheet in soil are difficult to determine*

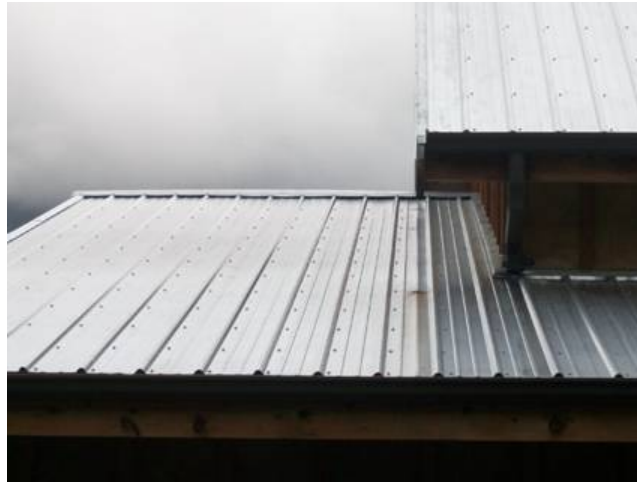
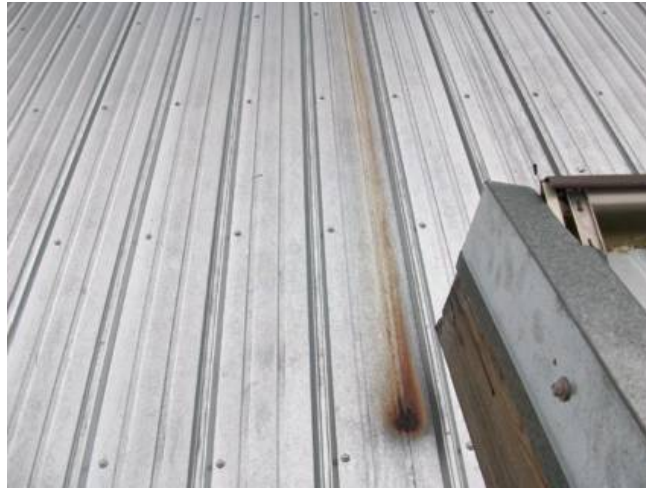
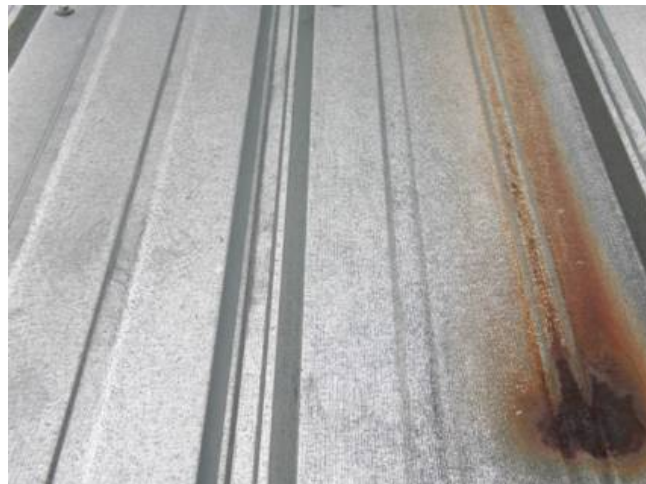
1.7 Accelerated Roof Corrosion from Runoff

Rusted area from water draining off a wood fascia (May 2010)

Especially on a roof, a very small amount of zinc is dissolved by rainwater and removed during each wetting event. If some portion of the roof receives extra water, draining from some higher, non-zinc coated surface, that extra water also takes its share of zinc (in addition to that taken by the rain that fell directly on it). The end result is the area of impingement has its zinc coating removed at a much higher rate, and the corroded area continues to grow in size.

Prevention: *In designing a structure, it is important to ensure that a particular exposed surface (roof elevation, side wall, etc.) always “sees” the same weather as uniformly as possible across the entire surface area. The above problem could have been avoided by cladding the wood fascia board with galvanized sheet. Water dripping off it would already be saturated with “its share” of zinc and would not have created the rust spot.*

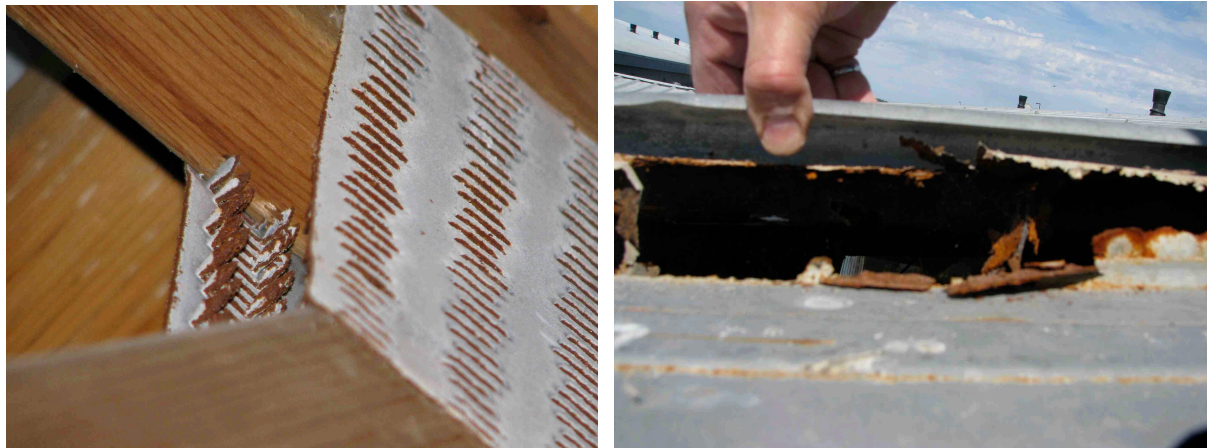
1.8 Building Corrosion from Excess Condensation

Corrosion in 3-Year Old Animal Confinement Building (August 2010)

The above two photos were taken from the same three-year-old animal confinement building. The G90 truss plates on the roof trusses (left photo) were severely corroded and the nearby roof sheeting had large perforated areas (right photo) that initiated from the inside. The cause of this very severe corrosion was quite likely an extreme build-up of very moist air laden with chemicals from animal waste products. During cold winter weather, a very corrosive condensate formed on exposed metal surfaces high in the structure, resulting in the aggressive attack shown in the photos.

Prevention: Have a building design that has sufficient and adequate ventilation, such that moisture cannot build up to the point where it can condense inside a structure. The exhaust system must both remove the moisture-laden air from inside the building, and not allow it to be entrained with replacement air.

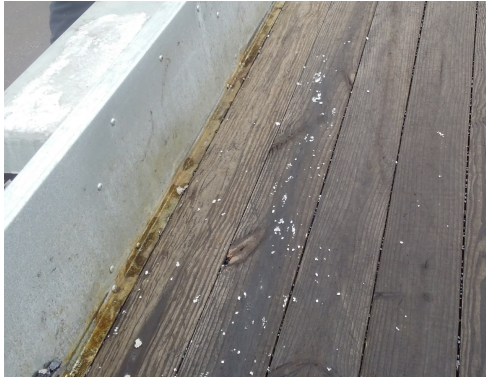
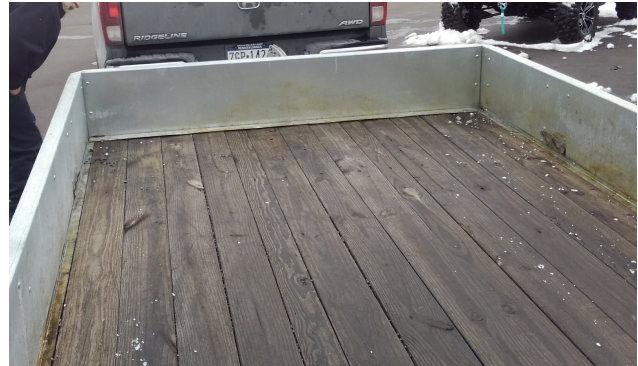
1.10 Corrosion on Utility Trailer with Galvanized Sidewalls

Corrosion on Galvanized Trailer Sidewalls (February 2018)

These photos show corrosion on the lower sidewall areas of a galvanized trailer, after transporting one load of loose coal. Note the attack is most severe on the flange where the sidewall is affixed to the wood floor (left photo). Coal contains 1–2% sulphur and is also hygroscopic. What likely happened was the wood floor was damp, allowing coal near it to absorb water. The sulphur in the coal reacted with the water to form small amounts of sulphuric acid, which quickly attacked the zinc. Sulphuric acid is very aggressive towards zinc.

Prevention: *If coal is conveyed in a galvanized trailer, the entire trailer should be galvanized, including the bottom. Also, the coal must be dry, and the load covered to prevent it getting wet during transit.*

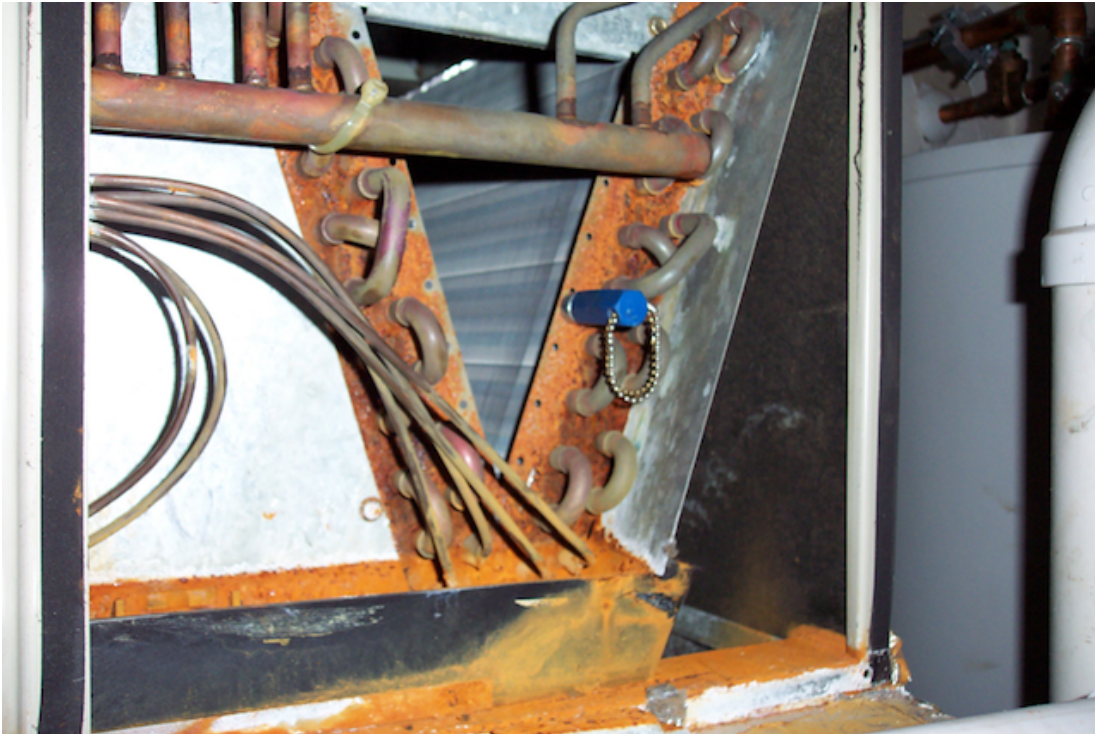
2.1 Corrosion of Air Conditioner

Galvanic corrosion of A/C unit galvanized end-plates and frame (October 2004)

A roof A/C unit in Indiana showed severe corrosion of galvanize end plates and frame after only 5 years on a roof in Indiana. Note the copper cooling tubes are in direct contact with the galvanize end plates. Also, the effluent-bearing copper ions run onto the galvanized frame.

Prevention: Copper must be electrically isolated from zinc, and water that has washed over copper cannot come in contact with zinc.

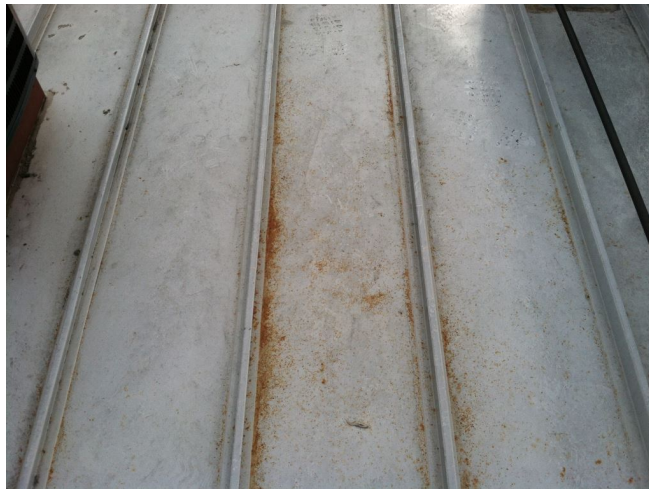
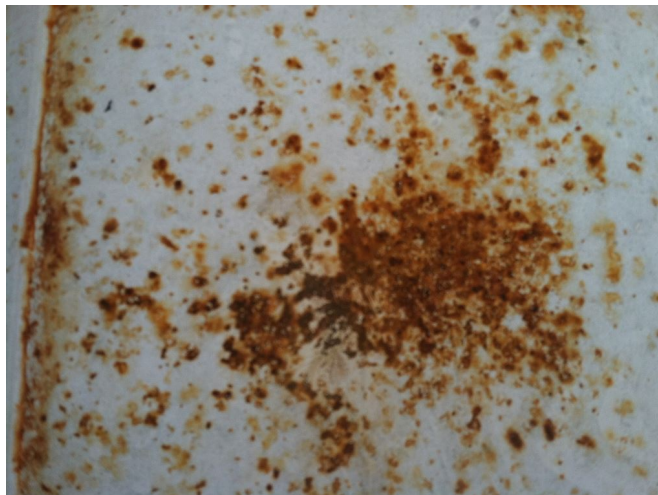
2.2 Cutting Debris (Swarf) Causing Corrosion on Prepainted Roof Panels

Red rust on top of prepainted roof panels (March 2014)

The above photos show red rust on a prefab building clad with roll formed, standing seam, prepainted sheet. The on-site work was the placement of A/C units on the roof. The contractor claimed no grinding or sawing was done to create debris that could rust, saying the panels must be defective. The photographs below show the nature of the condition. It is obvious, that regardless of the contractor's claim, what certainly looks like metallic debris has rusted on top of the paint.

Prevention: Insist that contractors are aware of the absolute need to do same-day complete clean-up and removal of metal cuttings (swarf) after work done installing, repairing, or other operations on or above a metal-clad building roof.

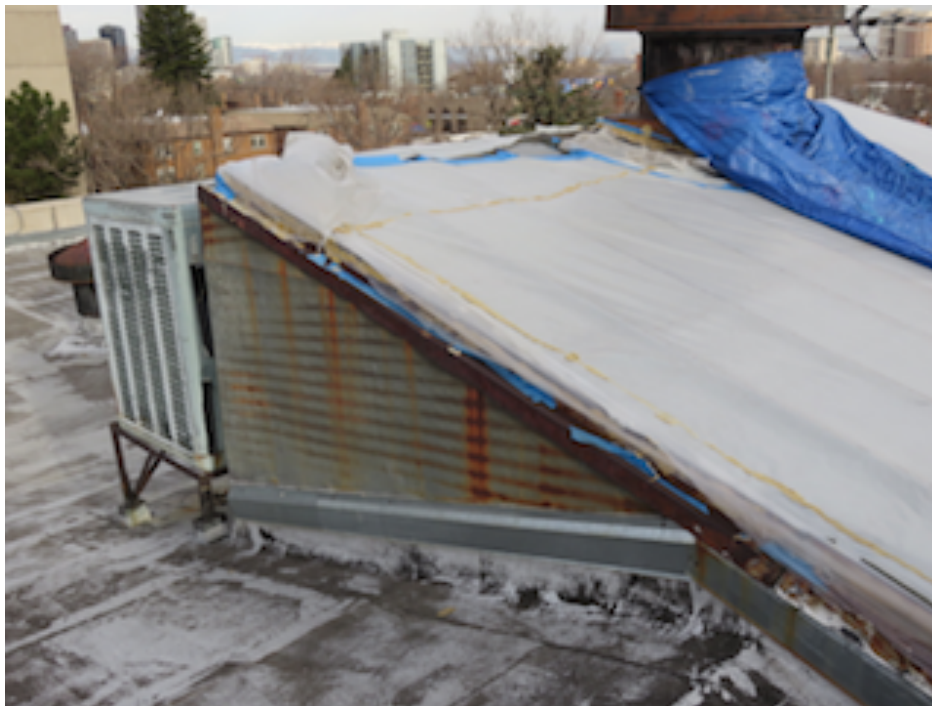
2.3 Bimetallic Corrosion on Roof Structure

Corroded galvanized roof structure in Denver (August 2017)

The uncoated angle iron along the top edge of the wall is the source of bimetallic corrosion because all water that drains down for it carries iron ions, which then attack the zinc from the surface.

Prevention: Do not let water drain from a non-zinc surface on to galvanized. In the above situation, the angle iron at the top should also be galvanized.

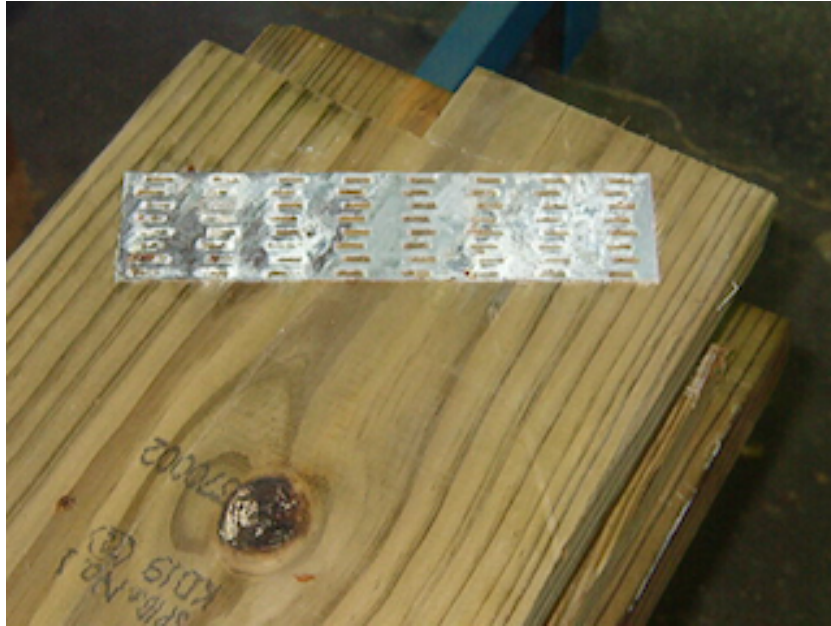
3.1 White Rust on Wood Connectors

Corrosion of galvanized connector plates used as an anti-split device for ACQ treated planks
(October 2005)

The plates are made using G185 and show white rust after 2 weeks in banded bundles of planks. When stacked, the connector plates were probably in contact with each other and white rust formed after they got wet. Also, increased galvanic corrosion from the large cut edge area resulting from the oblong holes accelerates the rate of zinc consumption.

Prevention: *The planks should be stacked either the plates cannot contact each other, or that plastic placed between the plates.*

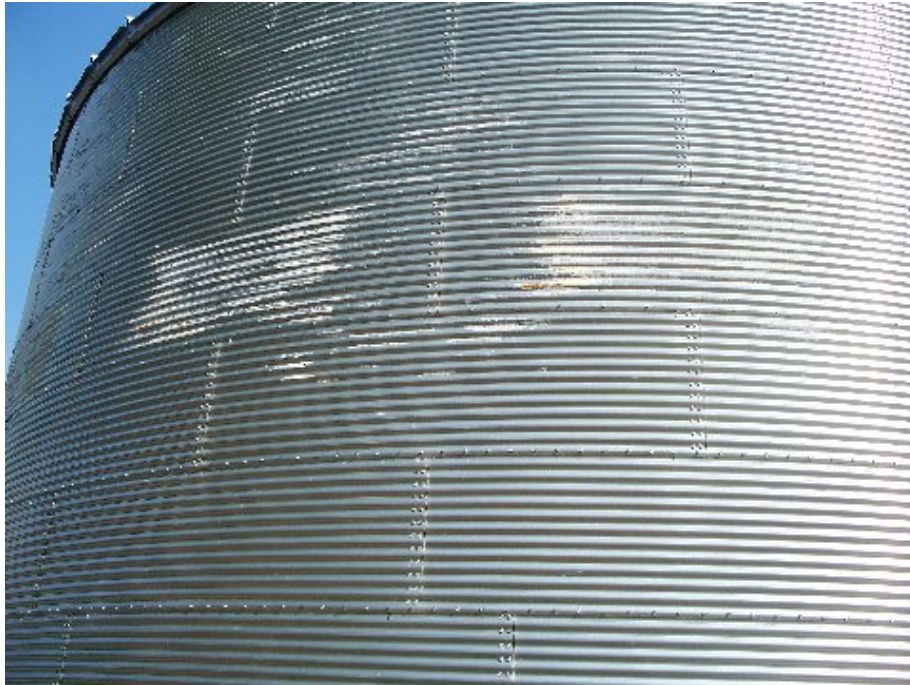
3.2 White Rust on Grain Bins

Storage stain on grain bin panels 3 years after erection (July 2010)

Grain bins with some panels showing severe white rust that was beginning to show red rust. A lawsuit against the supplier and/or erector was being considered. The panels had been stored outside for several weeks waiting to be erected in the fall of 2007. A painter had recently brought the rust to the attention of the farmer – it had not been noticed earlier! It is most likely that this damage had occurred in 2007 as a result of water damage. The affected panels were stained at the time of erection and should not have been installed. It is not the fault of the material.

Prevention: Grain bin panels are shipped to the field as curved, roll-formed panels. Typically, they are stored outdoors at the erection site. They should be stored **CONCAVE SIDE DOWN** to allow water drainage. Also, the erector should also be instructed to fabricate the bins as soon as possible.

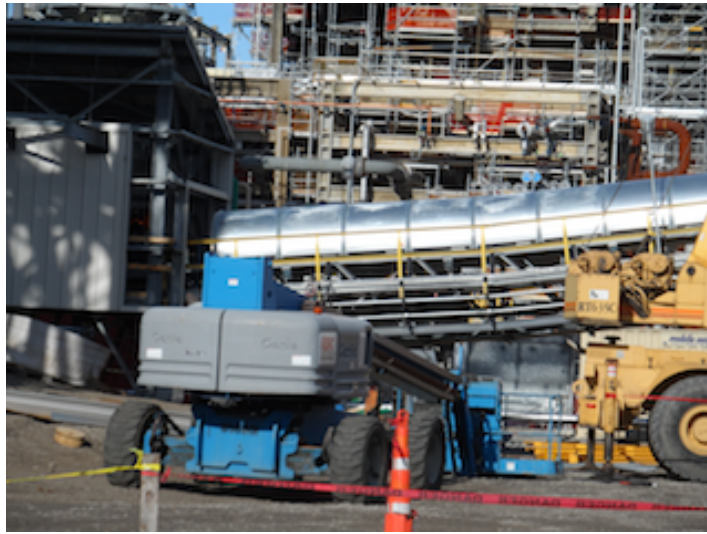
Panels installed at the building site (December 2012)

The covers for an outdoor conveyor line had white rust present when installed in early December. The packaged curved panels had been stored in an outdoor yard in Houston since April 2012. The photo showing the hoods in place indicates that the white rust condition may not be too severe. Actually, they have stood up quite well for having been shipped unprotected and stored outdoors for so long. There are two reasons for this. First, they were shipped, and stored with the panels vertical, so bulk water drained away

quickly. Had they been stored concave side up, it would have been a much worse. Second, the flange on each the side of the hoods kept the nearby surfaces from touching each other. That is why the white rust is only in the centre 1/3 of the hoods, as that is where the surfaces touched, where water could remain in contact with the surface, and would take a long time to dry. There are two hoods in the second photo that do not have any stain. They were probably the outer one in a package.

The chances are good that this material will be serviceable. Exposed to the atmosphere, the white rust will disappear and the zinc will do its normal job of protecting the steel against red rust. White rust on the inside will take longer to dissipate, but it's not visible and will not get worse.

Prevention: One thing the manufacturer could have done is put narrow plastic spacers 1/2 way around the circumference between the panels to keep them from touching. Shipped and stored like that, these panels could stay outdoors for years if needed with no water damage, because it's little different than a panel on a building. If galvanized parts must be stored outdoors, then making sure all surfaces have access to the atmosphere and can drain well is critical to avoid storage stain.

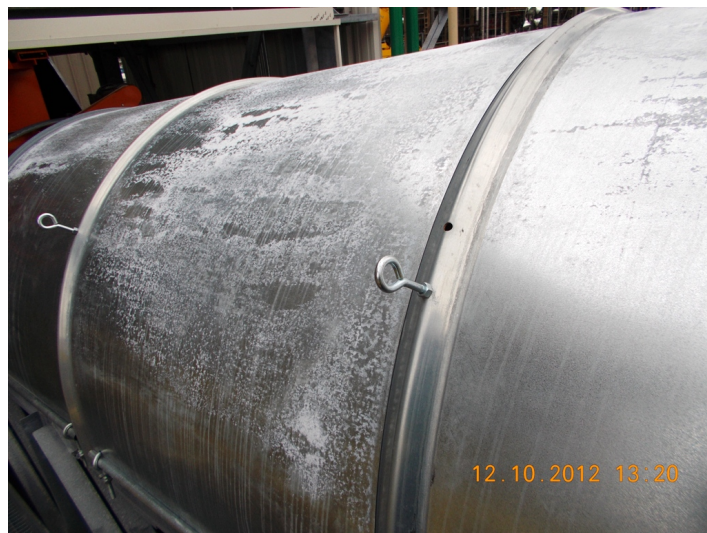
Close-up of storage stain on panels

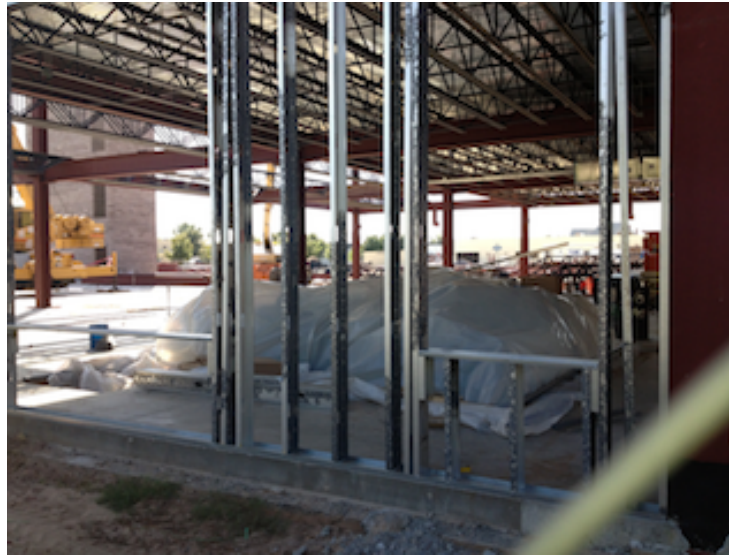
Black storage stain on installed framing (September 2013)

The first above depicts black storage stain on installed framing members. I told the caller that such severe staining had to have happened prior to installation. The second photo shows dried stain that was on two adjacent installed standing seam roof panels where the rest of the roof was stain-free. The pattern looks like a liquid had been spilled, beaded and then dried. EDX analysis had picked up potassium and chlorides.

Prevention: Installers should be trained not to install badly stained framing members.

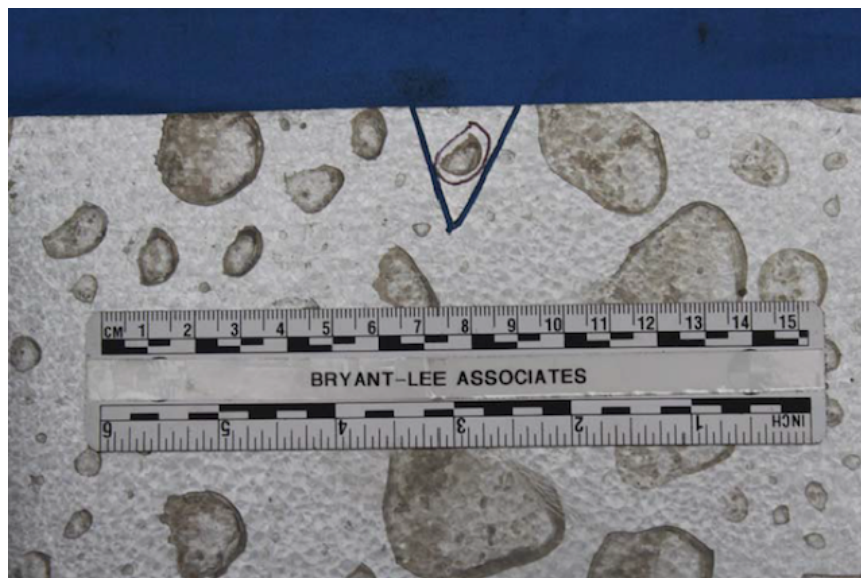
Dried stain on installed AZ standing seam roof panels (September 2013)

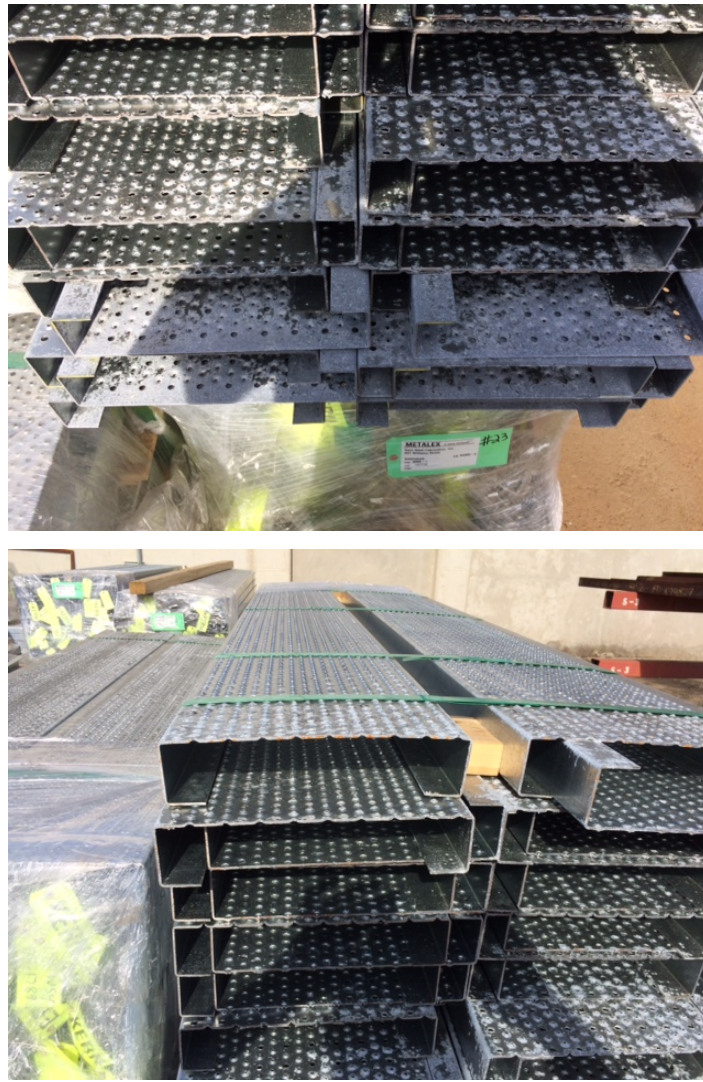
3.5 White Rust on Perforated C Channels

White rust on perforated C channels (February 2015)

Produced from galvanized sheet, which had been perforated and rolled formed. Material stored outside, or subject to severe wetness during transit, should not be stored in that condition. White rust occurred because water sat on the surface for an extended time. Zinc is a good protector when normal wet dry cycles are in play. When it's subjected to long times of wetness the corrosion mechanism changes. Thick white zinc hydroxide/oxide forms, rapidly consuming the zinc.

of 6 to 7) . In a wet state, the zinc was then doing double duty, sacrificing itself near the cut edges to protect the steel from rusting, and being rapidly consumed by the constant state of wetness.

Prevention: *The bundles, if received wet, should have then been oriented to be on at least a 20-degree angle to allow better drainage, and preferably each bundle should have been broken open and all the members separated and allowed to drain and dry. In short, this material somehow got wet and was left in that condition long enough for white rust to form. I was not the fault of the material.*

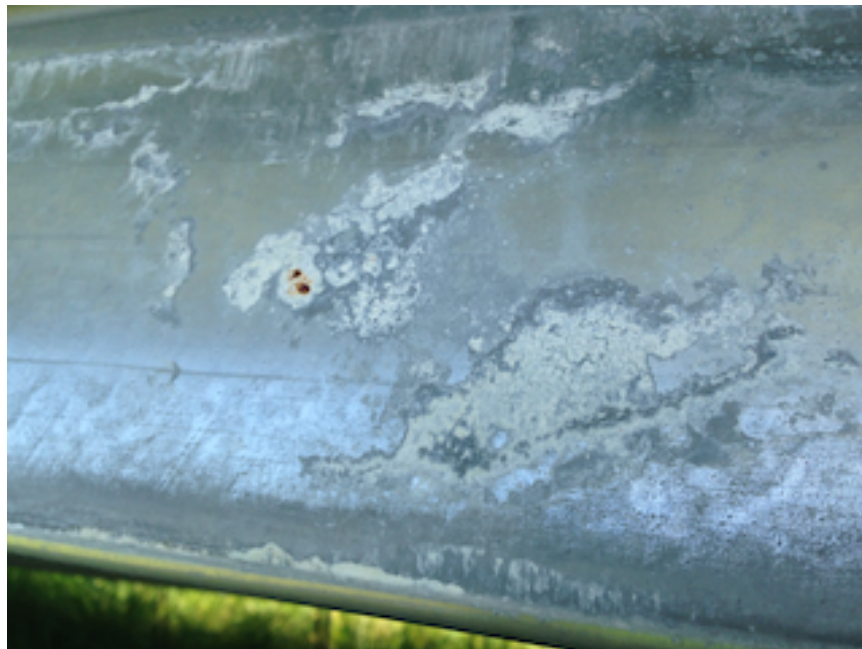
3.6 White Rust on G90 Purlins

White (and red) rust on G90 purlins stored outdoors. (July 2015)

Storage stain on G90 purlins stored outdoors in North Carolina. The staining appears to be related to roll forming solution left on the surface when packaged, aggravated by outdoor storage. The photo shows red rust in the center of one white stain patch. The pattern suggests aggressive corrosion not necessarily due to water coming in from the edges of the purlin, but from liquid already present.

Prevention: *Roll-formed galvanized sheet should be free of excess rolling lubricant before being bundled.*

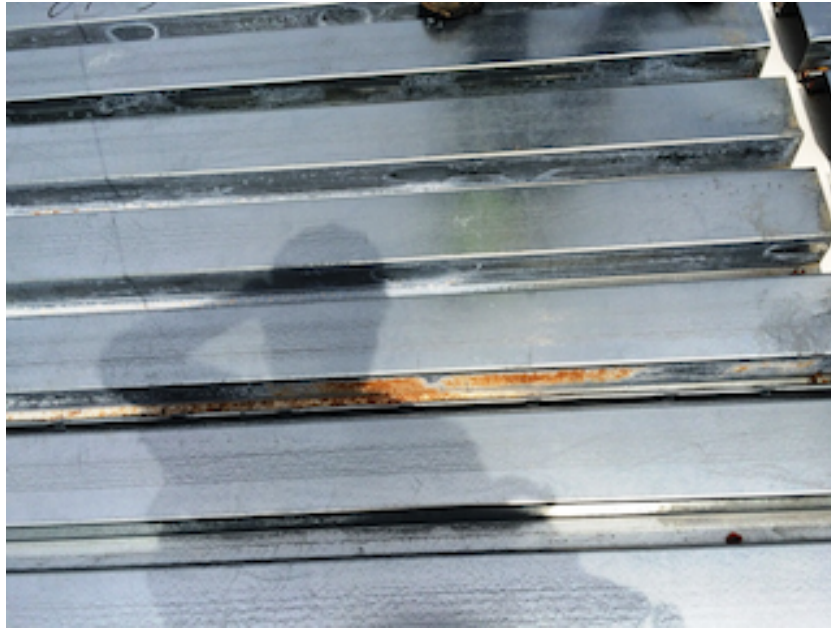
White and red rust on roof decking (October 2015)

Corrosion on roof deck panels in Panama, which is the result of water damage during transit and/or storage. In the top photo, the red rust in the channel was where two surfaces were probably touching in the stacked bundles. It was wet long enough for the zinc on the side of one channel to be consumed allowing red rust to form. In the second photo the bottom of some channels have extensive red rust, indicating that water was sitting there for considerable time.

Galvanized sheet cannot be expected to survive such treatment, especially in a warm, humid environment such as Panama.

Prevention: Roll-formed galvanized sheet in bundles must be protected from water damage.

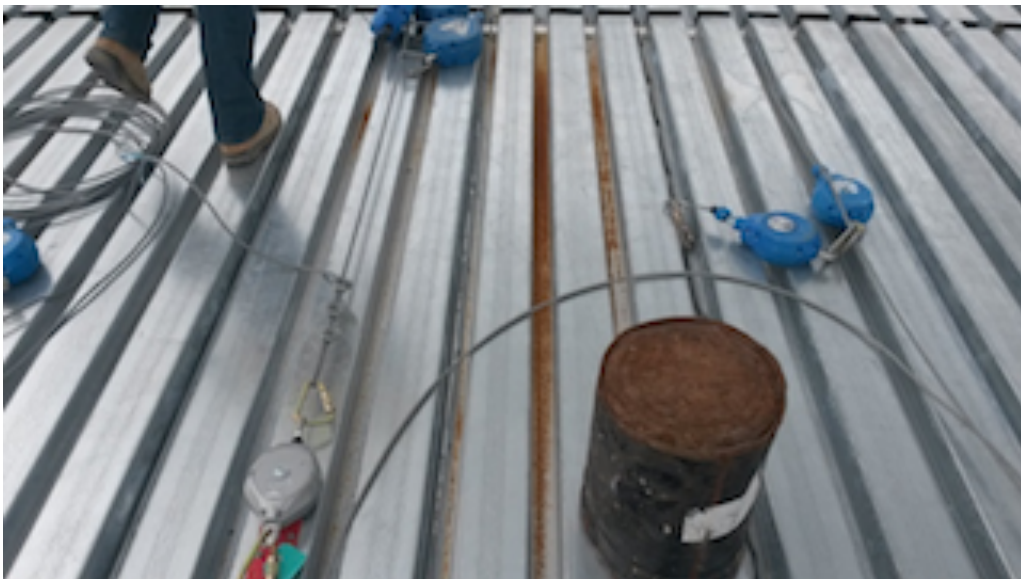
Red rust on the bottom channels of roof decking

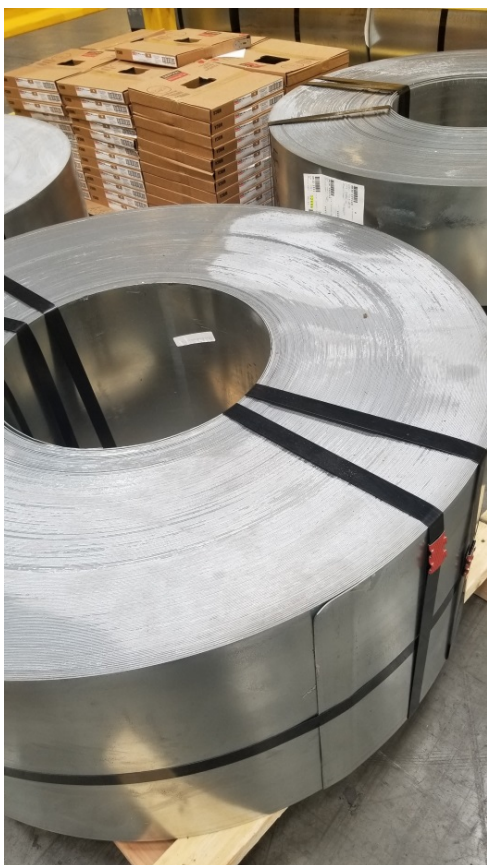
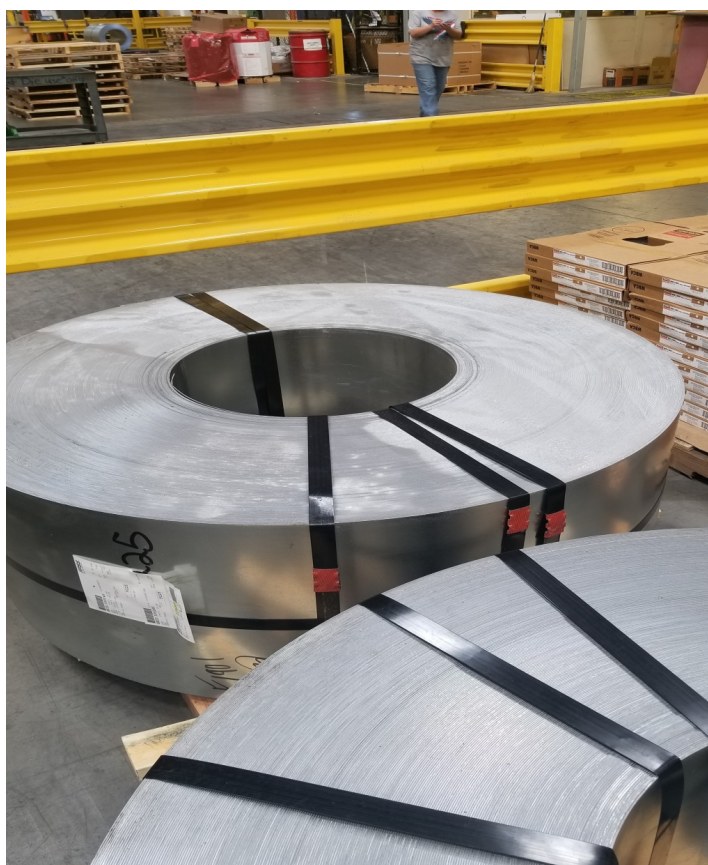
3.9 White Storage Stain Resulting from Condensation

White rust on the edges of slit coils after a 3+ day truck shipment from Stockton, CA to Texas
(October 2017)

Slit coils cut from passivated and oiled master coils in stock since 2014. The slit coils were shipped by truck from Stockton, CA to Texas, taking almost 4 days. How white rust could form on the edges? The likely cause was cooling of the steel, albeit unevenly, during its passage through the mountains. When it came in contact with warm and moist air after the mountains the temperature of the coils, or parts of them, could well have been below the ambient dew point,

which would allow moisture to form on the coolest areas of the coil surfaces. The cut edges would have unpassivated zinc exposed, on which white rust can form very quickly. In addition to the coating thickness being exposed on both surfaces of each lap in the coils, some zinc does smear down the cut edge during slitting. The material in this case was successfully processed, as white rust did not have time to form on the flat sheet surfaces.

Prevention: *Be aware that moving cold steel into warmer air runs the risk of moisture condensing on the surface.*

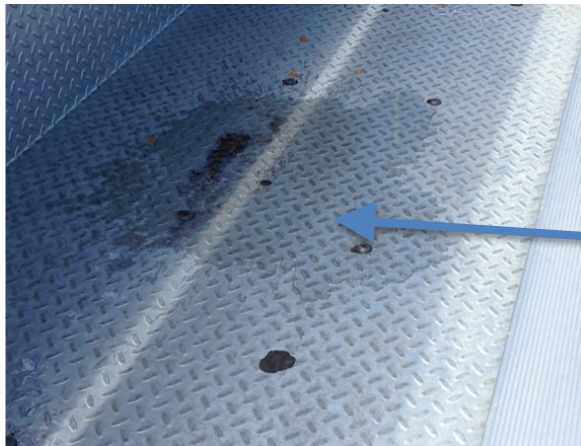
**Poor drainage interferes
with wet/dry cycles**

The above two photos are of a spectator viewing stand constructed using G90 galvanized tread plate. The horizontal walking surfaces were designed to be canted for drainage, but parts of some were fastened too tightly to the supporting structure, creating dished areas that prevented complete draining after rain events. This interferes with the normal wet/dry cycle times, which prevents the formation of the protective film of ZnCO_3 needed to slow the atmospheric corrosion rate of zinc.

Prevention: *Products made from G90 galvanized sheet for outdoor use require that all surfaces exposed to the weather have good drainage and dry relatively quickly after rain events. Allowing water to pool changes the corrosion mechanism such that white ZnOH forms, which can rapidly consume the coating. A G90 coating (~20 microns [0.0008"] thick on each surface) can last 25 to 30 years in a rural environment.*

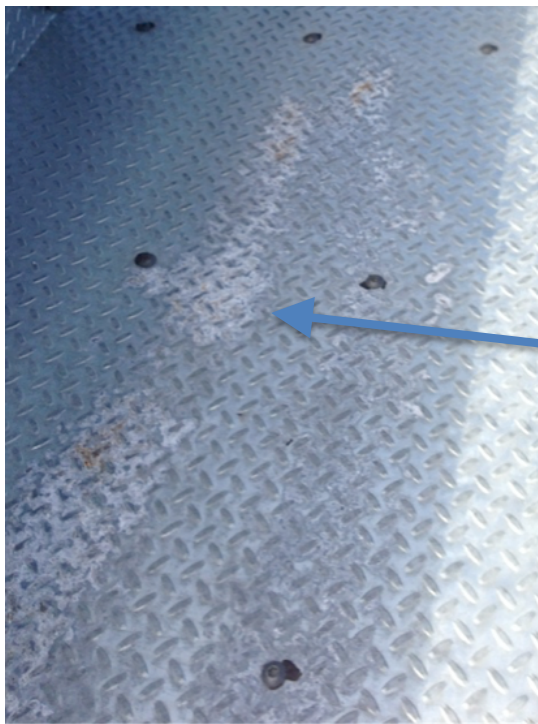
**Results in inability to form
 ZnCO_3 leading to rapid
zinc consumption**

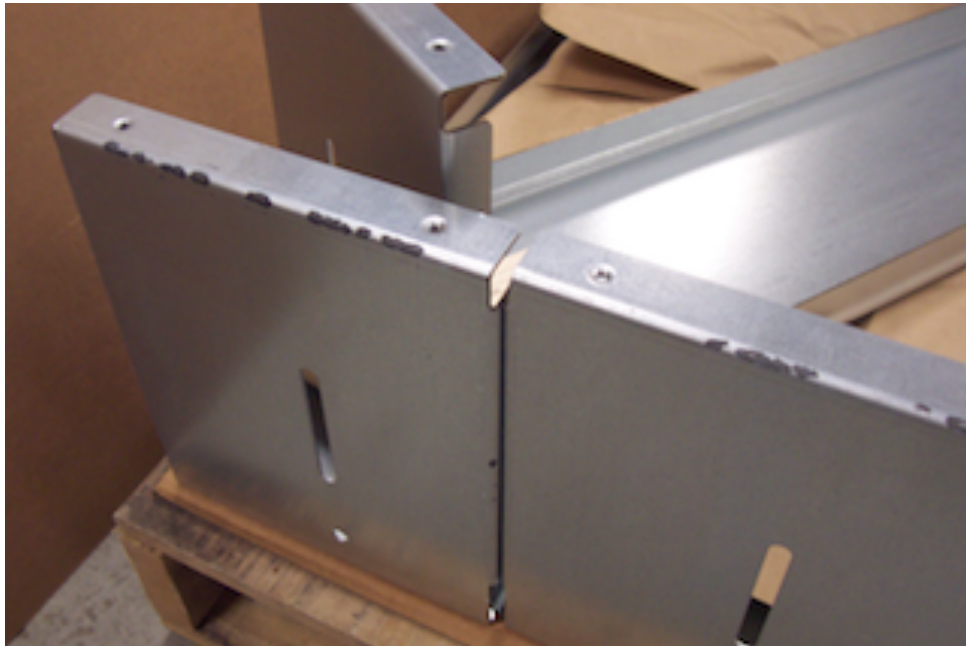
4.1 Fretting (Transit Abrasion) – Case 1

What first appears to be flaking at bends is actually black corrosion on the surface
(August 2011)

A parts manufacturer received a batch that had been formed then stored for 6 months. The photo shows the surface marks present, which when examined closely, look remarkably like a form of fretting corrosion. This happens without moisture present. The marks are most likely due to the zinc surfaces rubbing together during handling and shipping over the 6 months.

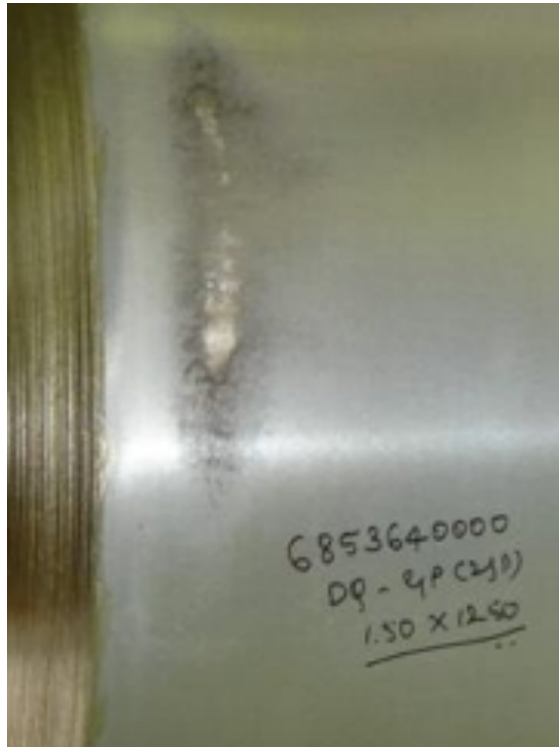
4.2 Fretting (Transit Abrasion) – Case 2

Fretting corrosion (transit abrasion) on a coil of galvanized steel (December 2008)

In the case of coil-form material shown above fretting marks are located exclusively in the weight-bearing area of contact of the saddle support that cradled the coil(s). The coil had been shipped with its eye horizontal and aligned perpendicular to the direction of movement. The fretting damage occurs under load and in the presence of repeated relative surface motion, as often induced by vibration.

Prevention: *In the case of coils, an action that is very effective is redesigning support saddles to reduce concentrated point loading on the bottom of coils. By distributing the weight of the coil over the entire area of the saddle(s), there is less pressure at any one point, resulting in less transit damage.*

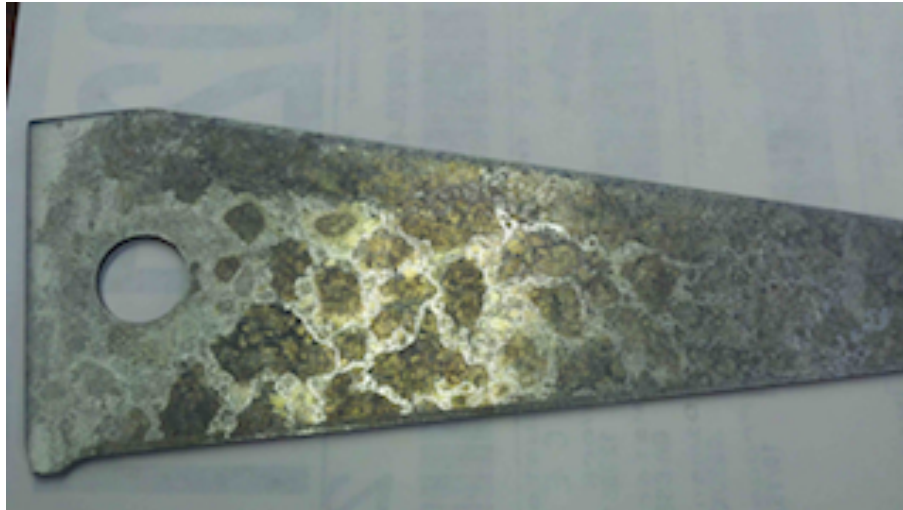
5.1 Darkening of Unpassivated Galvanize – Case 1

Extreme darkening on G90 (January 2012)

G90 galvanized that “rusted” in 3 days outdoors. The concerned that the product had a light coating. The condition was not rusting, but a fairly extreme example of darkening. The piece was in a scrap box outdoors. The less stained area at the left was covered by another piece. Moisture from dew condensing on the surface can cause a dark, zinc oxide stain, sometimes overnight, if the surface is non, or inadequately passivated. It is an appearance issue with very little zinc being consumed.

Prevention: *Unpassivated galvanize is subject to rapid superficial corrosion by condensate water. It should not be left in a location where dew can form on it.*

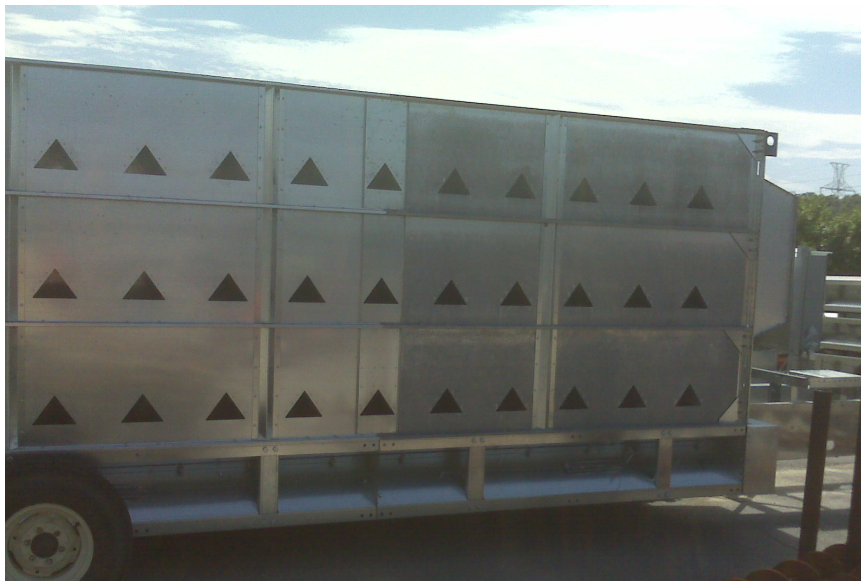
5.2 Darkening of Unpassivated Galvanize – Case 2

Darkened galvanize (right side) on grain handling equipment (July 2010)

Immediately after manufacture the above assembly was uniformly shiny. The material on the right side of the assembly darkened appreciably, compared to that on the left, during the first night outdoors. The galvanize used to make the bright area was mill passivated, while that used for the dark area was oiled before shipping, *but not passivated*. The significance of outdoor storage is that dew can condense on the surface of the metal. The darkening is the result of forming protective basic oxy-carbonate layers and is influenced by the presence of atmospheric species such as sulfates, which can change the appearance (darkness) of zinc. Heavy mists and dew absorb sulfates much more than rainwater. The latter has a higher degree of mineralization that can complex with sulfate ions, thus rendering it less aggressive than dew. Passivation on galvanize protects against rapid attack by dew water.
