International Zinc Association

Continuous Galvanized Steel Sheet

Corrosion Library

Selected Corrosion Issues Received by the GalvInfo Center as of:

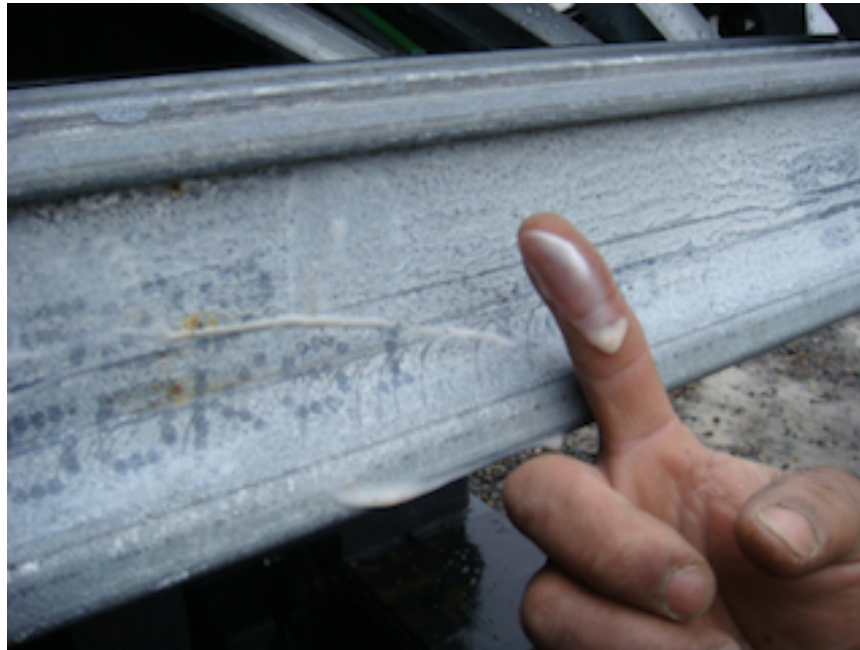
5.3 White Foam on Framing Members

Unknown “foam” on framing after getting wet in the field (January 2008)

A mysterious “foam” formed on G60 trusses after a rainfall. It only happened on one batch. Various inquiries did not come up with a root cause, although the most likely was thought to be an improperly cured acrylic passivating treatment.

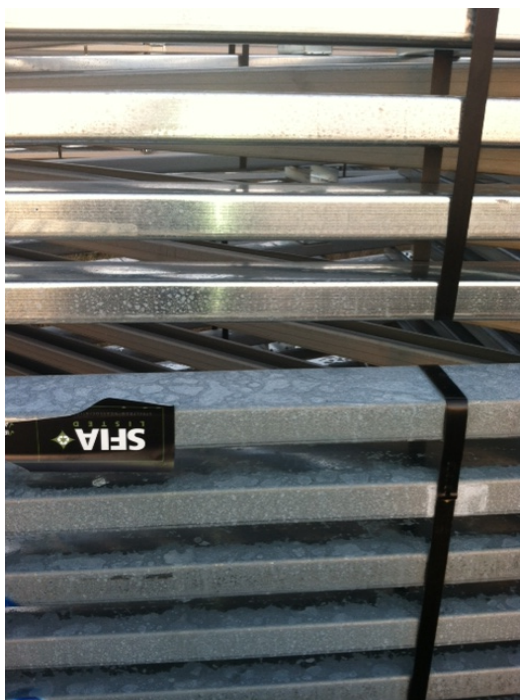
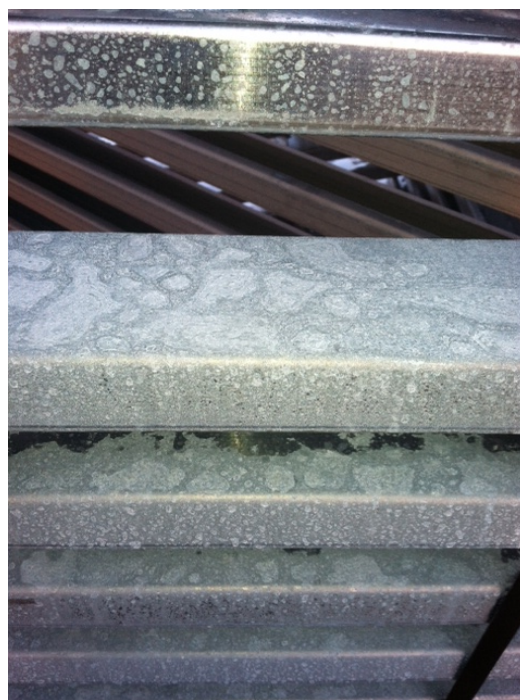
5.4 White Stain on Framing Members

White staining on stacked framing members (December 2013)

Framing members were produced, stacked (in a very favourable way) and stored outside, as is the company's usual practice. After a rain, the bundles were stained (shown above) after a day or two. The producer normally stores formed framing outside with no issues, as should be the case with passivated material stacked in such an open, and stain-resistant configuration. From the photos appears that only the lower members are stained, and they turned entirely white. There were different lots of material involved. Apparently, some Cr^{+3} passivates can be prone to this problem, perhaps if not cured properly or by reacting with roll forming lubricants.

Prevention: *Chromium⁺³ passivates need to be fully cured to be resistant to softening leading to staining problems.*
