Continuous Galvanized Steel Sheet

Corrosion Library

Selected Corrosion Issues Received by the GalvInfo Center as of:

Rev 2 April 2021

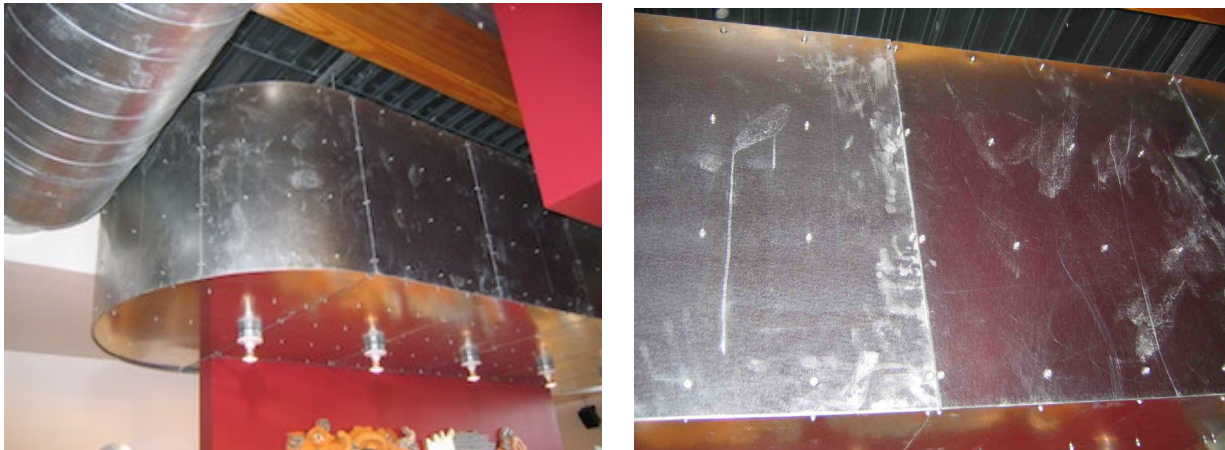
Fingerprinting on galvanized HVAC assembly (October 2004)

Perspiration from workers can dissolve some of the passivation film, allowing salt to react with the zinc, leaving the fingerprinting marks. These white stains are not entirely removable. Application of phosphoric acid may even out appearance but will dull the entire surface. An oxalic acid cleaner, "Bar Keepers Friend" is reported to be able to almost remove these stains.

Prevention: Use acrylic coated galvanize "Plus", or workers should wear gloves and long sleeves.

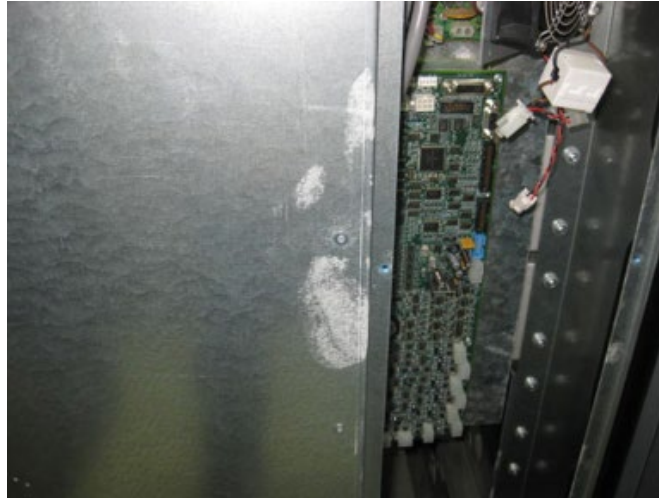
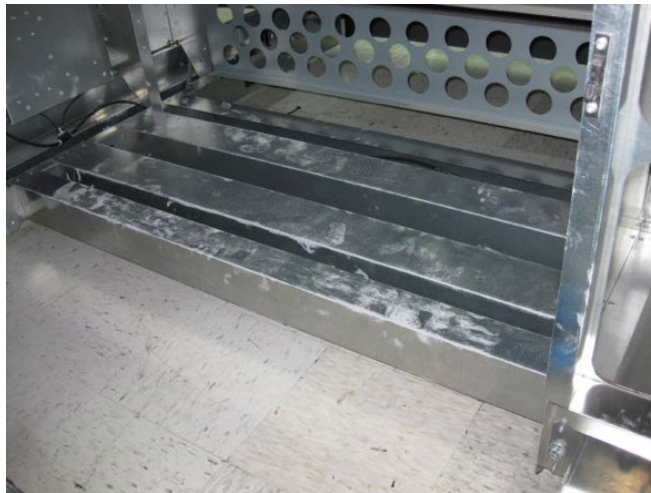
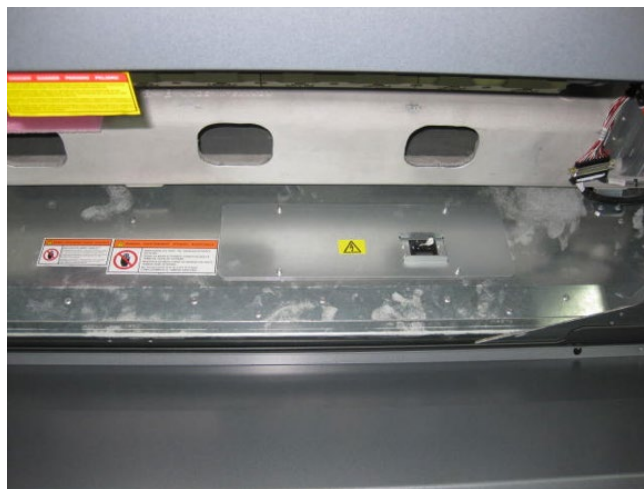
Fingerprinting on galvanized electronic equipment panels (November 2009)

Corrosion was seen on galvanized electronic equipment panels/frames after ocean vessel shipment from Asia. The initial concern was that water damage occurred in transit. The above

photos of the condition, however, have all the appearances of fingerprinting describe above that most likely occurred during assembly and/or handling of the equipment.

Prevention: Use acrylic coated galvanize "Plus", or workers should wear gloves and long sleeves.

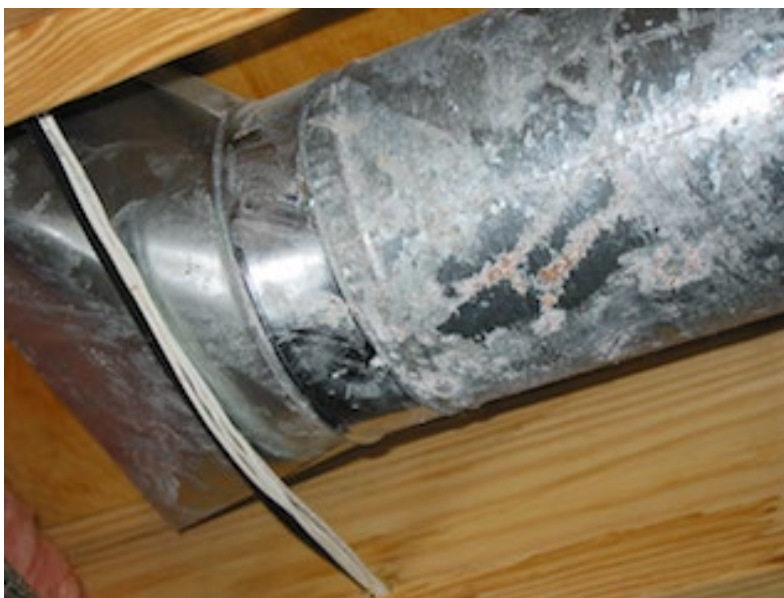
Corroded residential ductwork (March 2005)

The galvanized ductwork in the entire basement of a private home mysteriously corroded to the point of red rust in some locations. As the photo below shows, it was attacked by an aggressive substance. Apparently, there was a small roof leak that entered one register, but the extent and severity of the damage is inconsistent with plain water coming in contact with the ductwork. One possibility is that the leaking water dissolved aggressive chemicals from the wood in the house before it reached the zinc.

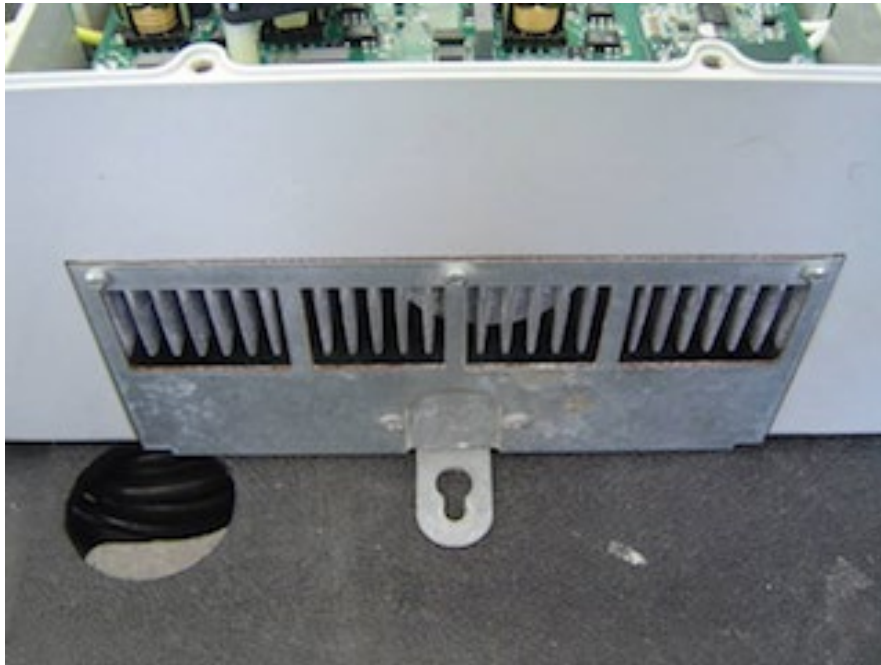
Cosmetic rust on the sheared edges of 0.080" G90 in a greenhouse environment
(March 2009)

The concern was the rust on the shear-cut edge, and would a heavier coating prevent it. In such an environment, edge rust would always occur on sheet as thick as this, but it would not progress beyond the extent in the above photo until the nearby zinc was consumed. A thicker zinc coating would delay this.

Prevention: To completely prevent edge rust, post HD galvanizing would be necessary. Painting the edges with zinc-rich paint would delay it significantly.

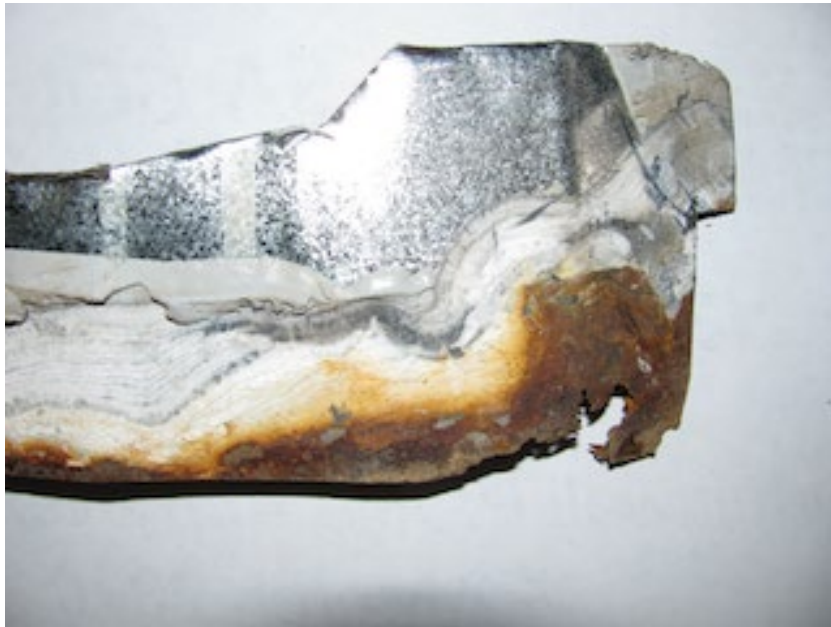
Corrosion on galvanized flashing close to the ground on a stucco wall (April 2010)

A corrosion problem encountered on G90 flashing at the bottom of stucco walls in resort buildings in California. Corrosion is proceeding from the bottom up. “Beach marks” in the white corrosion product indicate cyclic attacks, similar to fatigue crack failure. It is likely related to soil chemistry and repeated wetting events from both irrigation and rain.

Prevention: Soil near the base of a wall should be covered with stones or paved over to prevent moisture splashing on the flashing during irrigation or rainfall.

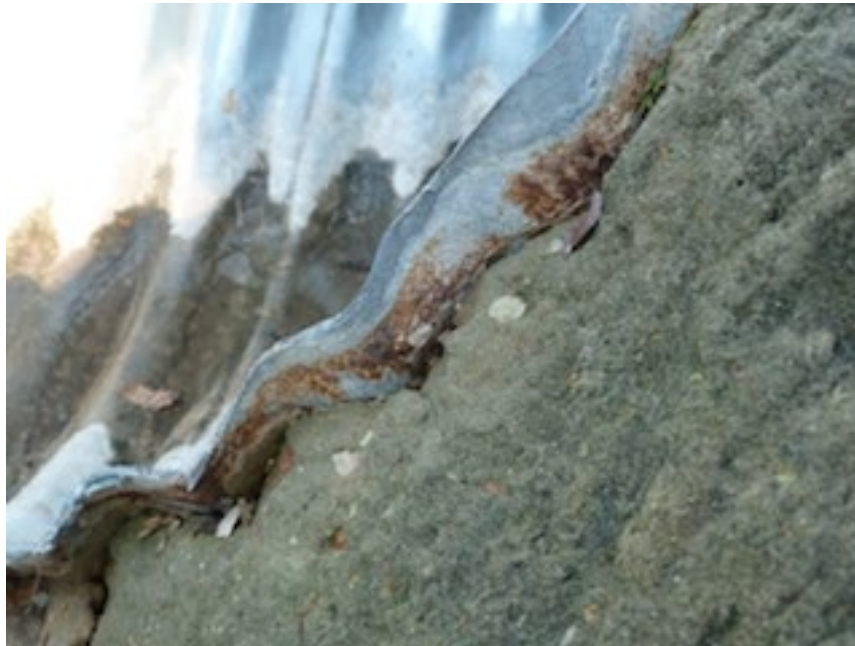
Soil-side corrosion on culvert pipe (January 2012)

Soil-side corrosion in culvert pipe after 3 years. The pipe was laid in cement-stabilized sand and the corrosion revealed itself after a flood that washed some of the sand back from the end. The environment against the outside of the pipe must have been constantly wet to get such a degree of corrosion in such a short time. It may just be a condition close to the end of pipe due to dripping.

Prevention: *Unknown. Due to the myriad types of soil conditions that exist, viz., widely varying chloride and moisture contents, and pH levels, the solution to corrosion issues of galvanized sheet in soil are difficult to determine*

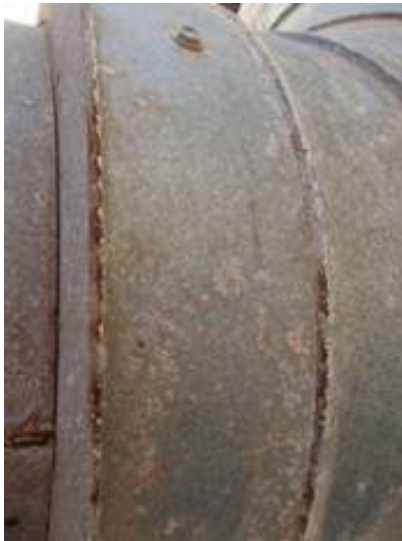
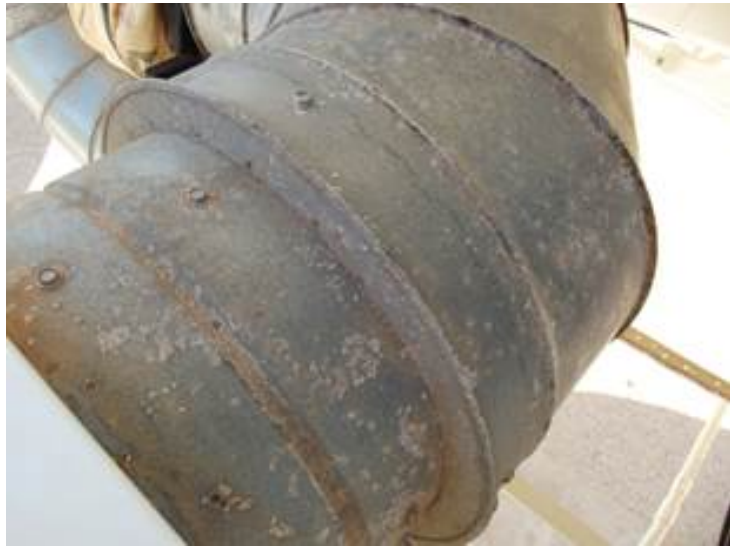
Surface of G90 HVAC located about 1 mile from the coast of Western Australia
(October 2015)

The photos illustrate red and white rust in G90 HVAC piping installed about a year earlier on a building about a mile from the west coast of Australia. About 2-3 months before the photos were taken a cyclone passed through the area. The rust was noticed about one month after that. The supplier said the red colour was nothing more than surface iron from annealing in the mill and the underlying zinc and steel were unaffected. That was an incorrect assessment. The photos showed very aggressive, likely chloride, attack of the zinc. This may be an environment that is too aggressive for G90.

Prevention: *In designing equipment that will be boldly exposed to a potential severe chloride environment, chose a material that can stand up to the conditions.*

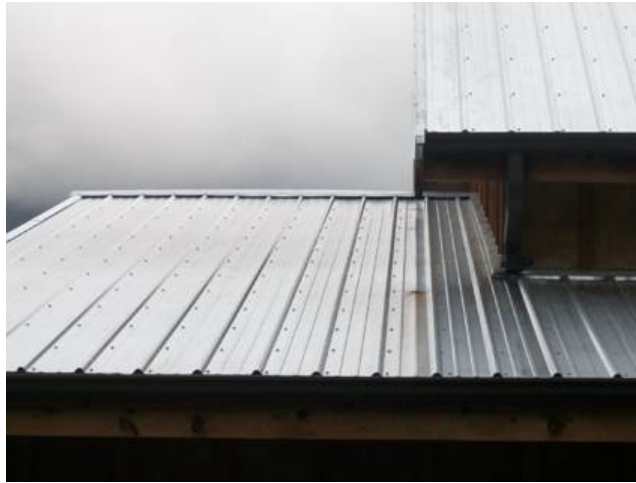
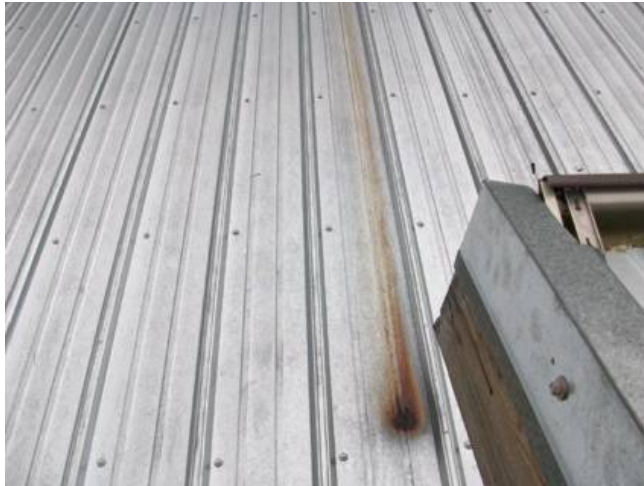
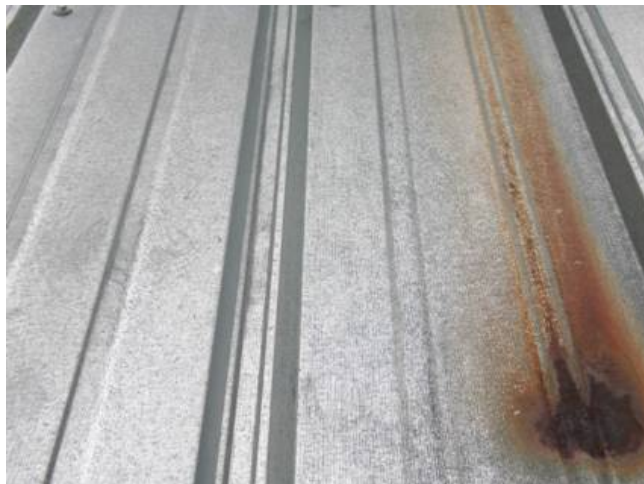
Rusted area from water draining off a wood fascia (May 2010)

Especially on a roof, a very small amount of zinc is dissolved by rainwater and removed during each wetting event. If some portion of the roof receives extra water, draining from some higher, non-zinc coated surface, that extra water also takes its share of zinc (in addition to that taken by the rain that fell directly on it). The end result is the area of impingement has its zinc coating removed at a much higher rate, aided by erosion from falling water, and the corroded area gradually grows in size.

Prevention: *In designing a structure, it is important to ensure that a particular exposed metal surface (roof elevation, side wall, etc.) always “sees” the same weather as uniformly as possible across the entire area. The above problem could have been avoided by cladding the wood fascia board with galvanized sheet. Water dripping off it would already be saturated with “its share” of zinc and would not have created the rust spot.*

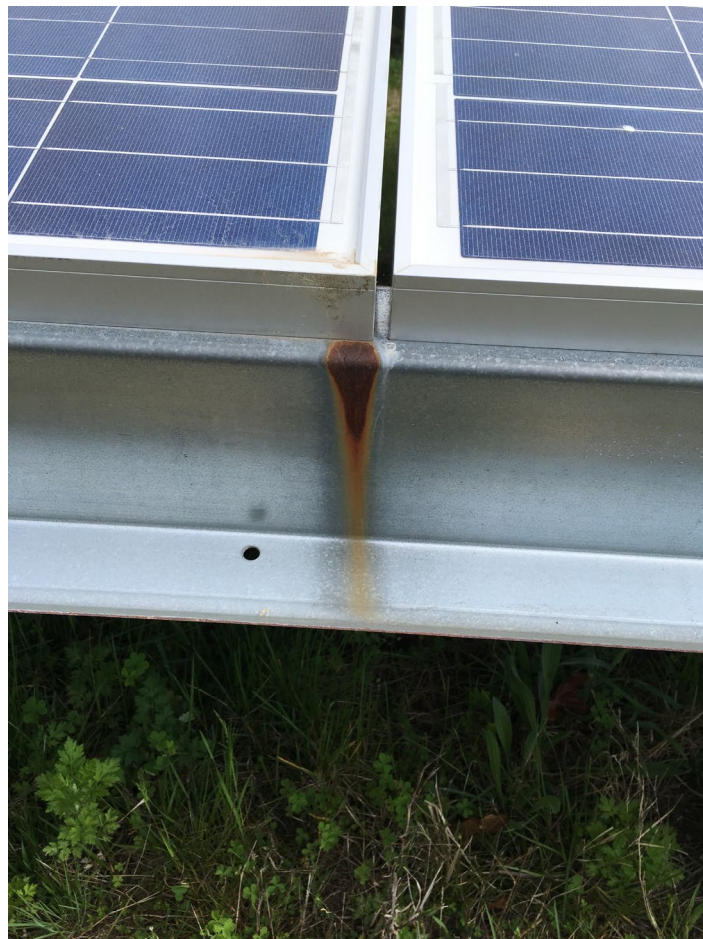
Corrosion of galvanized support of aluminium-framed solar panels (July 2018)

The downward and left to right tilt of the solar panels results in all the rainwater falling on a single panel draining to the lower right corner of the aluminum frame, then spilling onto one small area of the galvanized steel support rail. This accelerates the removal of the zinc coating from this one spot and the surfaces below it, due to the lack of any zinc in the water coming off the glass and aluminium panel. The stream of water concentrated over such a small region also accelerates erosion of the surface.

Prevention: This situation could have been avoided by either using aluminum support frames (perhaps not economical), or providing a drain channel/spout directing water away from the galvanized frame. To remedy the problem on the current structure, one method would be to repair the rusted areas with zinc-rich paint or thermal zinc spraying, then install replaceable zinc coated “splash pads” over the areas to receive the drain water and direct it away from the frame. These could be made from G165 or G185 galvanized sheet to last longer before needing to be replaced.

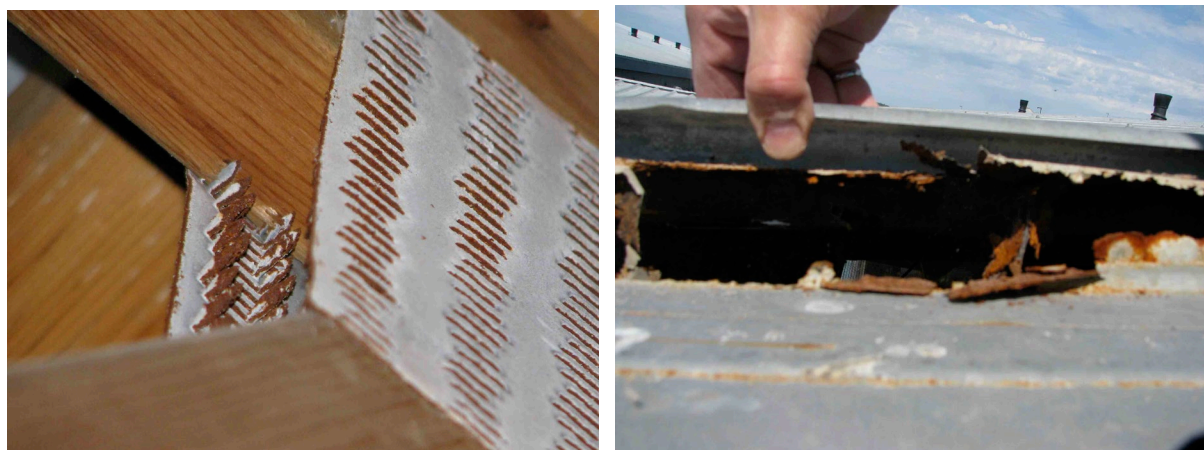
Corrosion in 3-Year Old Animal Confinement Building – Western Canada (August 2010)

The above two photos were taken from the same three-year-old animal confinement building. The G90 truss plates on the roof trusses (left photo) were severely corroded and the nearby roof sheeting had large perforated areas (right photo) that initiated from the inside. The cause of this very severe corrosion was quite likely an extreme build-up of very moist air laden with chemicals from animal waste products. During cold winter weather, a very corrosive condensate formed on exposed metal surfaces high in the structure, resulting in the aggressive attack shown in the photos.

Prevention: Have a building design that has sufficient and adequate ventilation, such that moisture cannot build up to the point where it can condense inside a structure. The exhaust system must both remove the moisture-laden air from inside the building, and not allow it to be entrained with replacement air.

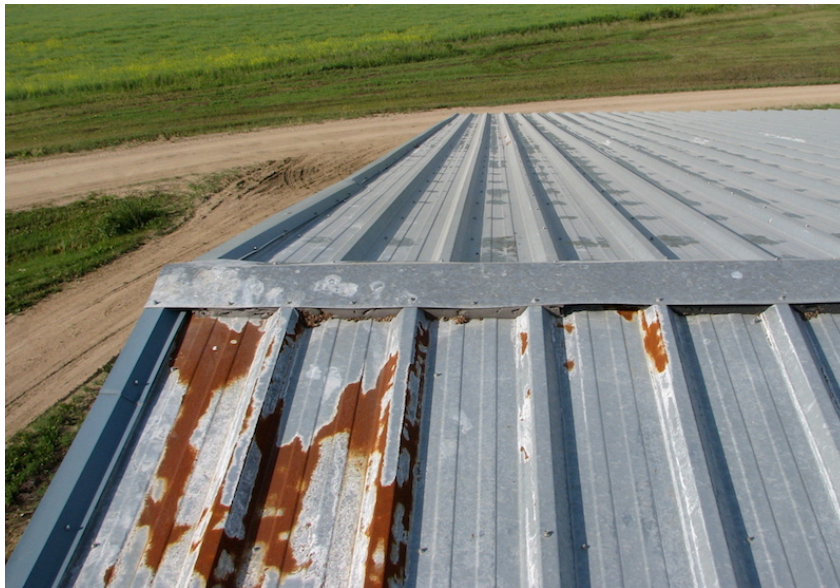
Corrosion on Farm Building Roof (August 2010)

This photo shows the result of dust residue from an animal feed chute collecting on the roof. After being wet for weeks or more, corrosion cells form.

Prevention: The removal of loose debris such as leaves, dirt or building effluent (grain dust or chaff around roof vents), etc., is important. Even if these residues do not contain corrosive chemicals, they still become wet, which prevents the quick drying and allows corrosion cells to set up. Zinc surfaces must be kept free of debris build-up by regular maintenance.

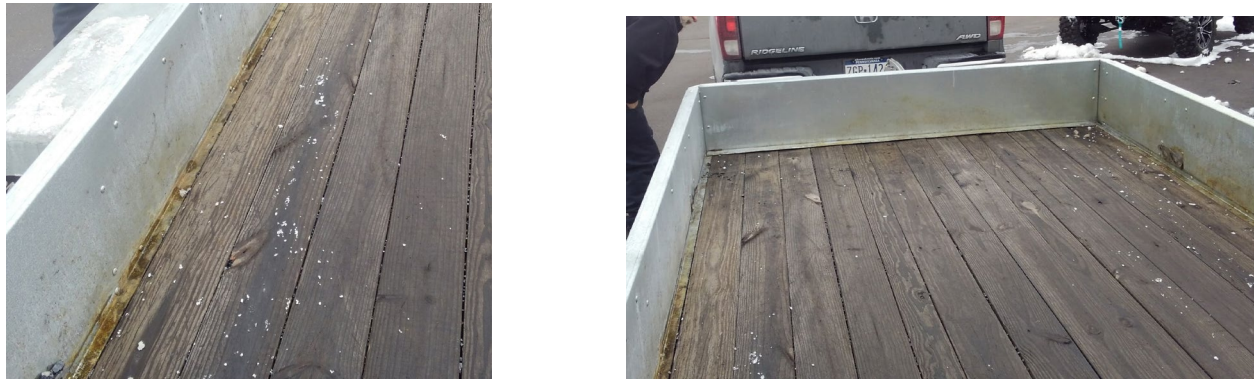
Corrosion on Galvanized Trailer Sidewalls (January 2018)

These photos show corrosion on the lower sidewall areas of a galvanized trailer, after transporting one load of loose coal. Note the attack is most severe on the flange where the sidewall is affixed to the wood floor (left photo). Coal contains 1–2% sulphur and is also hygroscopic. What likely happened was the wood floor was damp, allowing coal near it to absorb water. The sulphur in the coal reacted with the water to form small amounts of sulphuric acid, which quickly attacked the zinc. Sulphuric acid is very aggressive towards zinc.

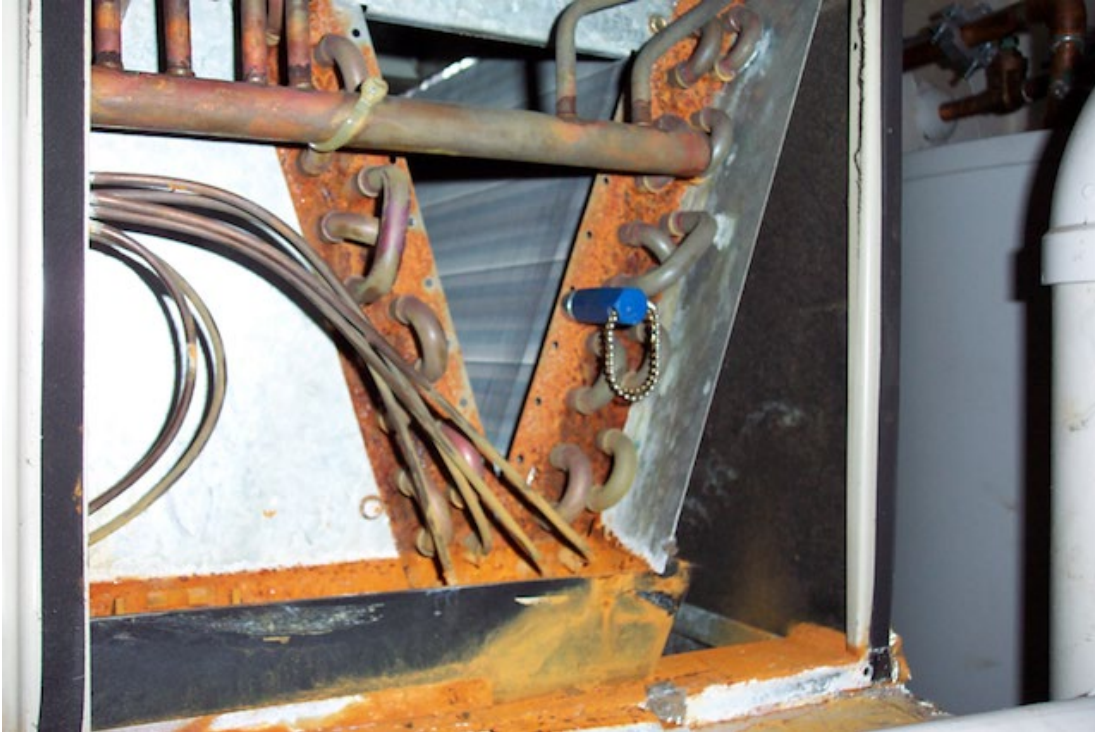
Galvanic corrosion of A/C unit galvanized end-plates and frame (October 2004)

A roof A/C unit showed severe corrosion of galvanize end plates and frame after only 5 years on a roof in Indiana. Note the copper cooling tubes are in direct contact with the galvanize end plates. Also, the effluent-bearing copper ions run onto the galvanized frame.

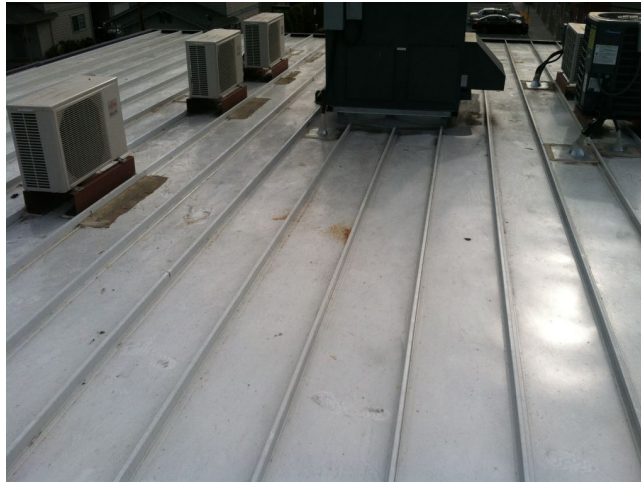
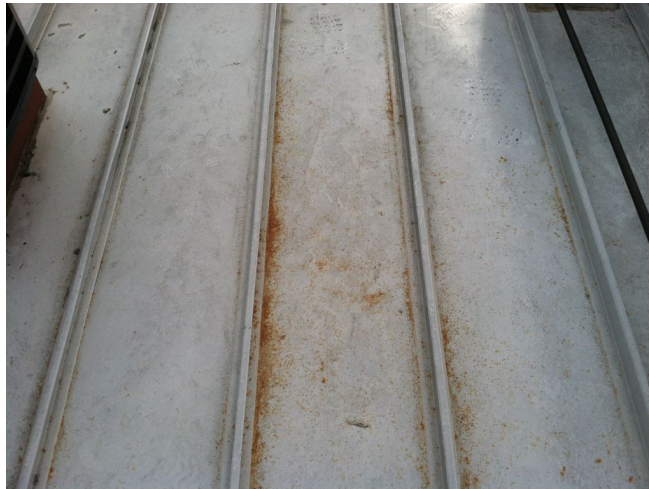
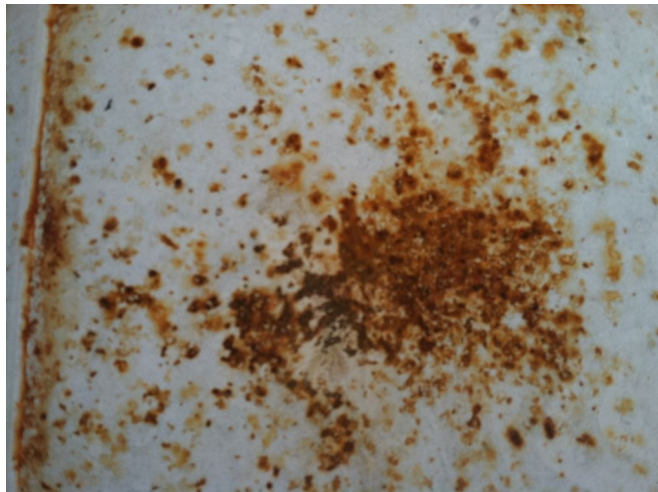
Red rust on top of prepainted roof panels (March 2014)

The above photos show red rust on a prefab building clad with roll formed, standing seam, prepainted sheet. The on-site work was the placement of A/C units on the roof. The contractor claimed no grinding or sawing was done to create debris that could rust, saying the panels must be defective. The photographs below show the nature of the condition. It is obvious, that regardless of the contractor's claim, what certainly looks like metallic debris has rusted on top of the paint.

Prevention: Insist that contractors are aware of the absolute need to do same-day complete clean-up and removal of metal cuttings (swarf) after work done installing, repairing, or other operations on or above a metal-clad building roof.

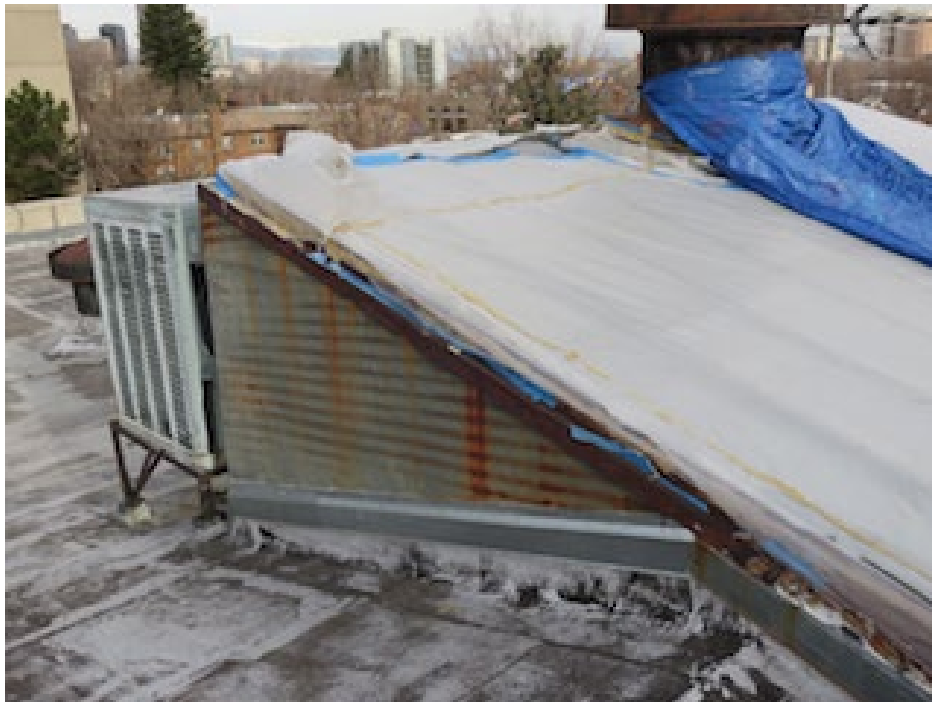
Corroded galvanized roof structure in Denver (August 2017)

The uncoated angle iron along the top edge of the wall is the source of bimetallic corrosion, because all water that drains down for it carries iron ions, which then attack the zinc from the surface.

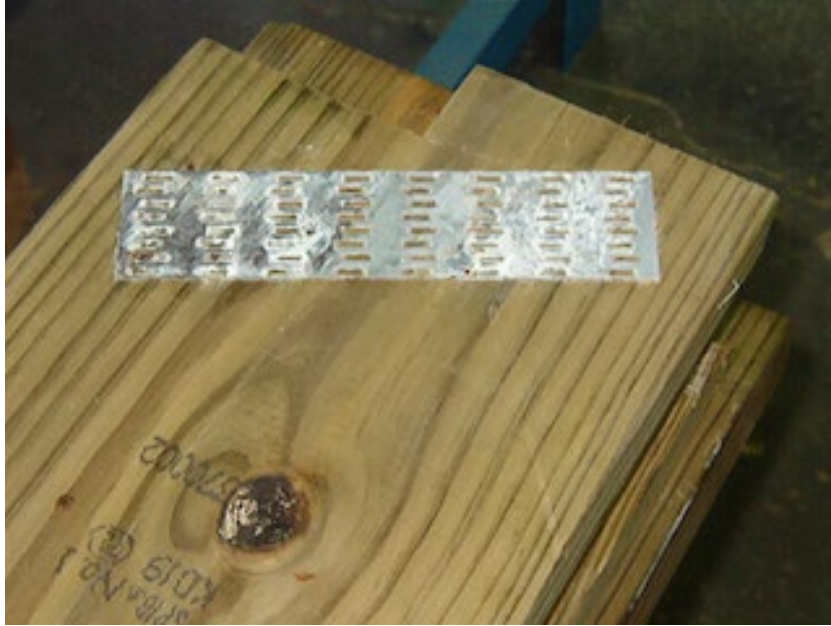
Corrosion of galvanized connector plates used as an anti-split device for ACQ treated planks
(October 2005)

The plates are made using G185 and show white rust after 2 weeks in banded bundles of planks. When stacked, the connector plates were probably in contact with each other and white rust formed after they got wet. Also, increased galvanic corrosion from the large cut edge area resulting from the oblong holes accelerates the rate of zinc consumption.

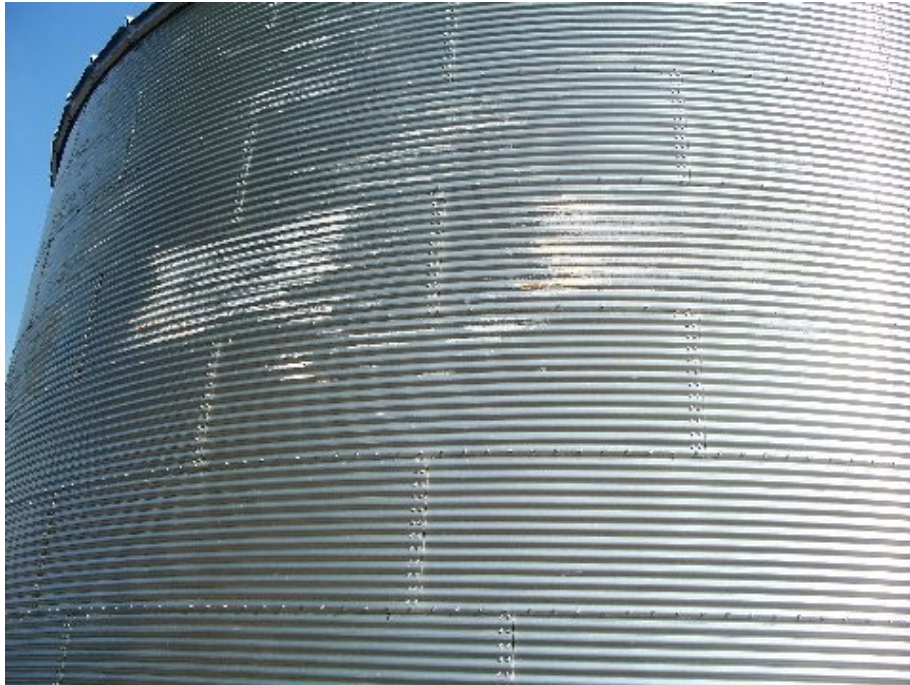
Storage stain on grain bin panels 3 years after erection (July 2010)

Grain bins with some panels showing severe white rust that was beginning to show red rust. A lawsuit against the supplier and/or erector was being considered. The panels had been stored outside for several weeks waiting to be erected in the fall of 2007. A painter had recently brought the rust to the attention of the farmer – it had not been noticed earlier! It is most likely that this damage had occurred in 2007 as a result of water damage. The affected panels were stained at the time of erection and should not have been installed. It is not the fault of the material.

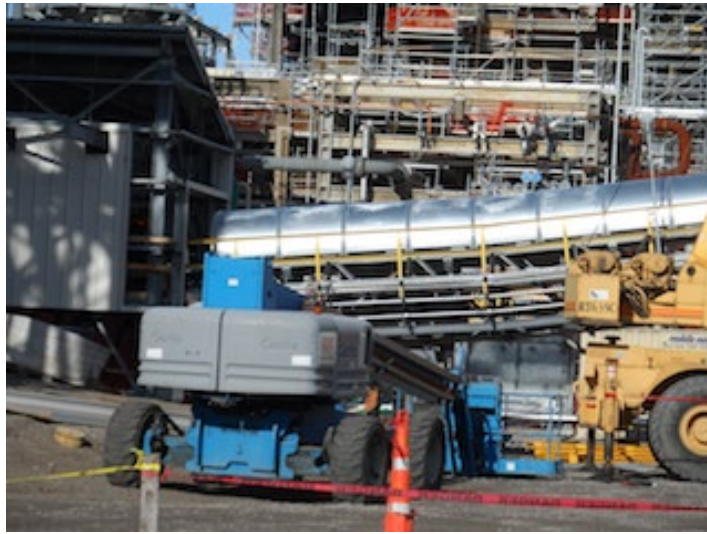
Panels installed at the building site (December 2012)

The covers for an outdoor conveyor line had white rust present when installed in early December. The packaged curved panels had been stored in an outdoor yard in Houston since April 2012. The photo showing the hoods in place indicates that the white rust condition may not be too severe. Actually, they have stood up quite well for having been shipped unprotected and stored outdoors for so long. There are two reasons for this. First, they were shipped, and stored with the panels vertical, so bulk water drained away

quickly. Had they been stored concave side up, it would have been a much worse. Second, the flange on each the side of the hoods kept the nearby surfaces from touching each other. That is why the white rust is only in the centre 1/3 of the hoods, as that is where the surfaces touched, where water could remain in contact with the surface, and would take a long time to dry. There are two hoods in the second photo that do not have any stain. They were probably the outer one in a package.

The chances are good that this material will be serviceable. Exposed to the atmosphere, the white rust will disappear and the zinc will do its normal job of protecting the steel against red rust. White rust on the inside will take longer to dissipate, but it's not visible and will not get worse.

Prevention: One thing the manufacturer could have done is put narrow plastic spacers 1/2 way around the circumference between the panels to keep them from touching. Shipped and stored like that, these panels could stay outdoors for years if needed with no water damage, because it's little different than a panel on a building. If galvanized parts must be stored outdoors, then making sure all surfaces have access to the atmosphere and can drain well is critical to avoid storage stain.

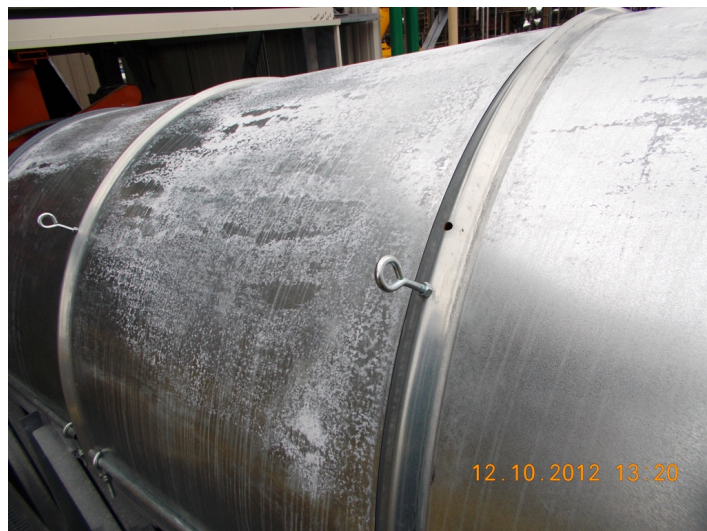
Close-up of storage stain on panels

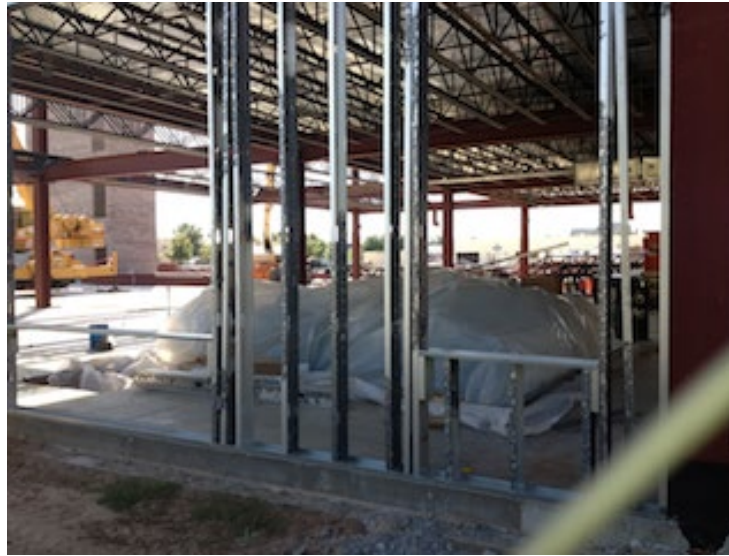
Black storage stain on installed framing (September 2013)

The first above depicts black storage stain on installed framing members. It is most likely that such severe staining happened prior to installation. The second photo shows dried stain that was on two adjacent installed standing seam roof panels where the rest of the roof was stain-free. The pattern looks like a liquid had been spilled, beaded and then dried. EDX analysis had picked up potassium and chlorides.

Prevention: Installers should be trained not to install badly stained framing members.

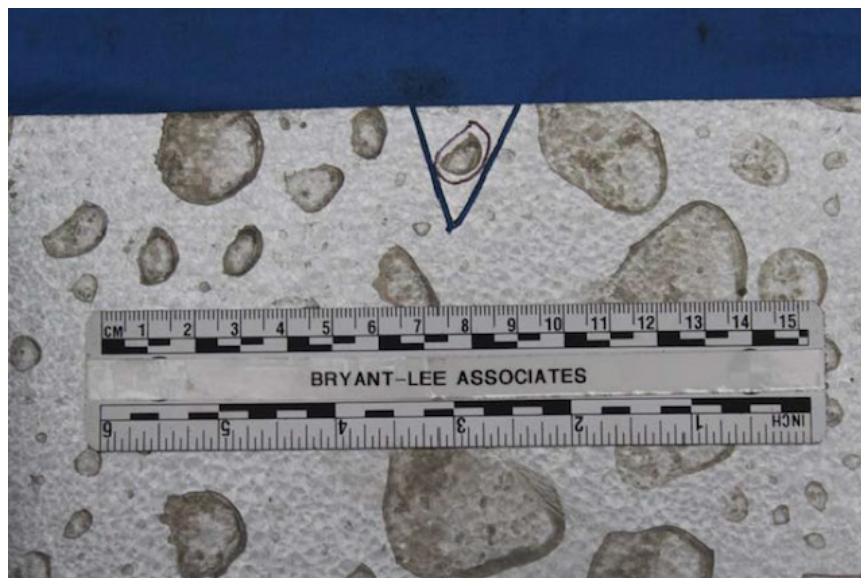
Dried stain on installed AZ standing seam roof panels (September 2013)

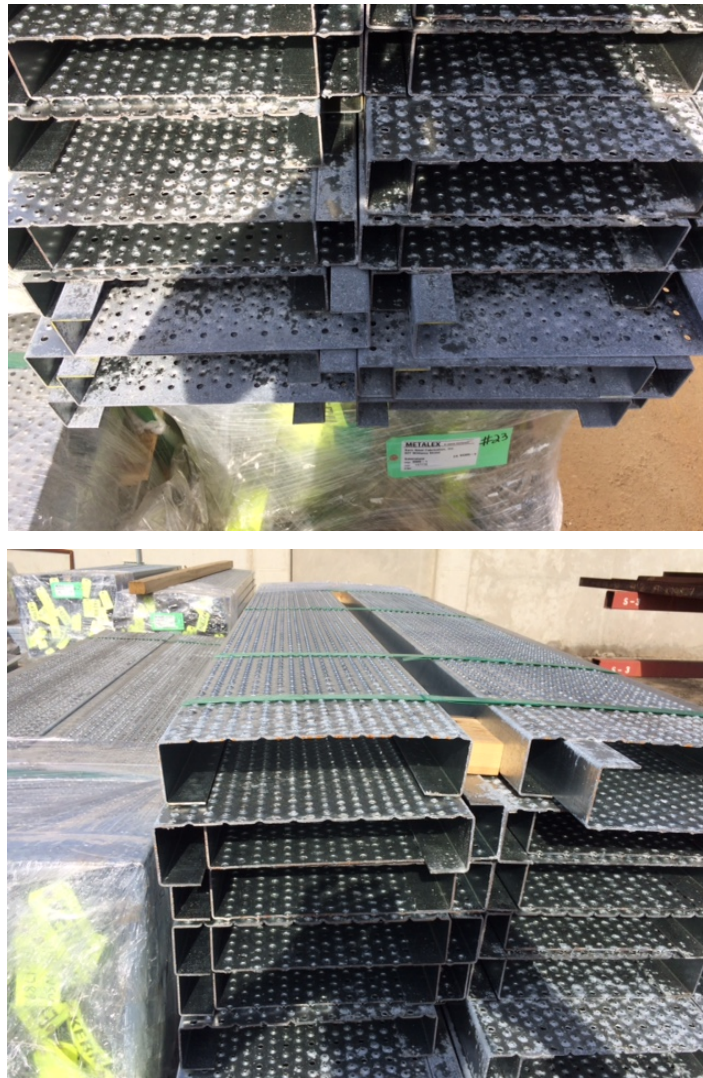
White rust on perforated C channels (February 2015)

Produced from galvanized sheet, which had been perforated and rolled formed. Material stored outside, or subject to severe wetness during transit, should not be stored in that condition. White rust occurred because water sat on the surface for an extended time. Zinc is a good protector when normal wet dry cycles are in play. When it's subjected to long times of wetness the corrosion mechanism changes. Thick white zinc hydroxide/oxide forms, rapidly consuming the zinc.

perforations exposed much more edges than on non-perforated panels (by an estimated factor of 6 to 7). In a wet state, the zinc was then doing double duty, sacrificing itself near the cut edges to protect the steel from rusting, and being rapidly consumed by the constant state of wetness.

Prevention: The bundles, if received wet, should have then been oriented to be on at least a 20-degree angle to allow better drainage, and preferably each bundle should have been broken open and all the members separated and allowed to drain and dry. In short, this material somehow got wet and was left in that condition long enough for white rust to form. I was not the fault of the material.

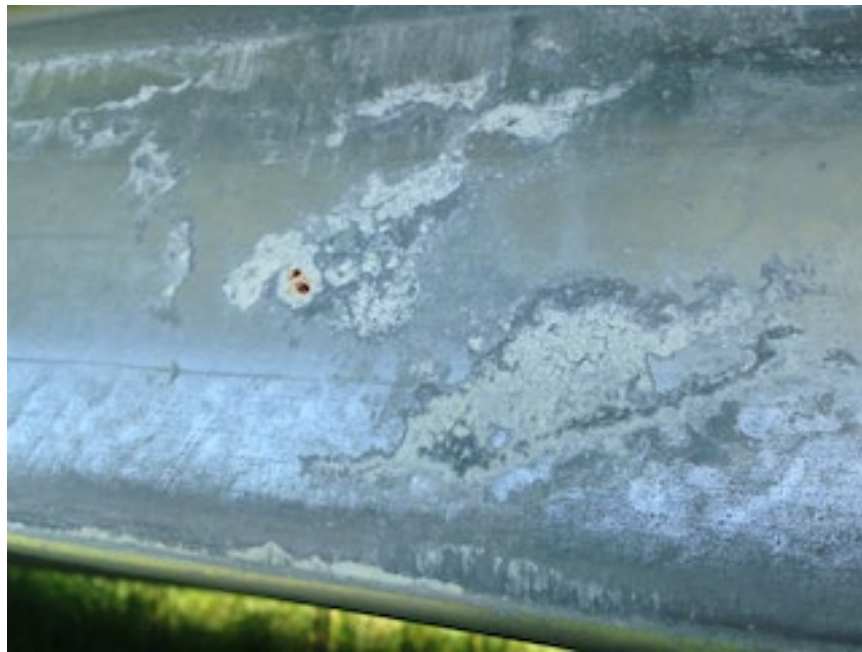
White (and red) rust on G90 purlins stored outdoors (July 2015)

Storage stain on G90 purlins stored outdoors in North Carolina. The staining appears to be related to roll forming solution left on the surface when packaged, aggravated by outdoor storage. The photo shows red rust in the center of one white stain patch. The pattern suggests aggressive corrosion not necessarily due to water coming in from the edges of the purlin, but from liquid already present.

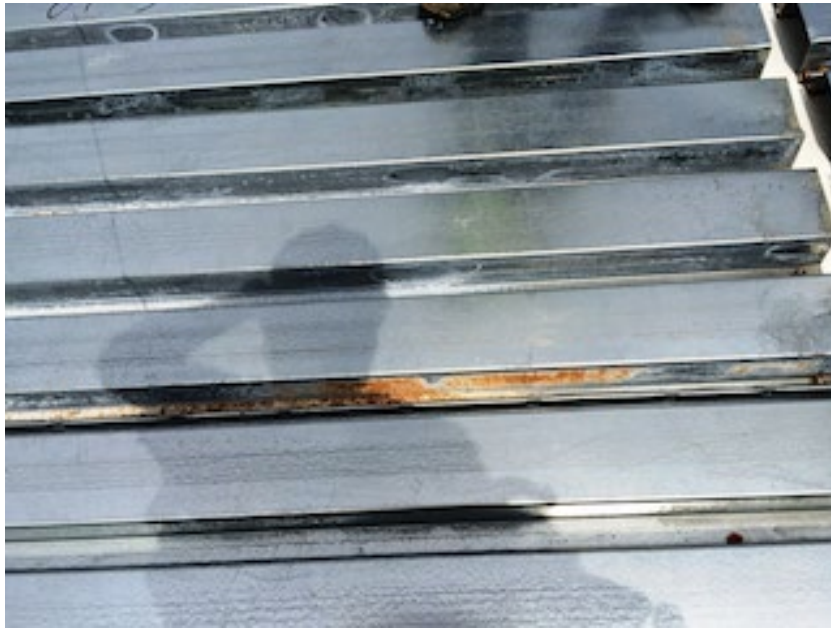
White and red rust on roof decking (October 2015)

Corrosion on roof deck panels in Panama, which is the result of water damage during transit and/or storage. In the top photo, the red rust in the channel was where two surfaces were probably touching in the stacked bundles. It was wet long enough for the zinc on the side of one channel to be consumed allowing red rust to form. In the second photo the bottom of some channels have extensive red rust, indicating that water was sitting there for considerable time.

Galvanized sheet cannot be expected to survive such treatment, especially in a warm, humid environment such as Panama.

Prevention: Roll-formed galvanized sheet in bundles must be protected from water damage.

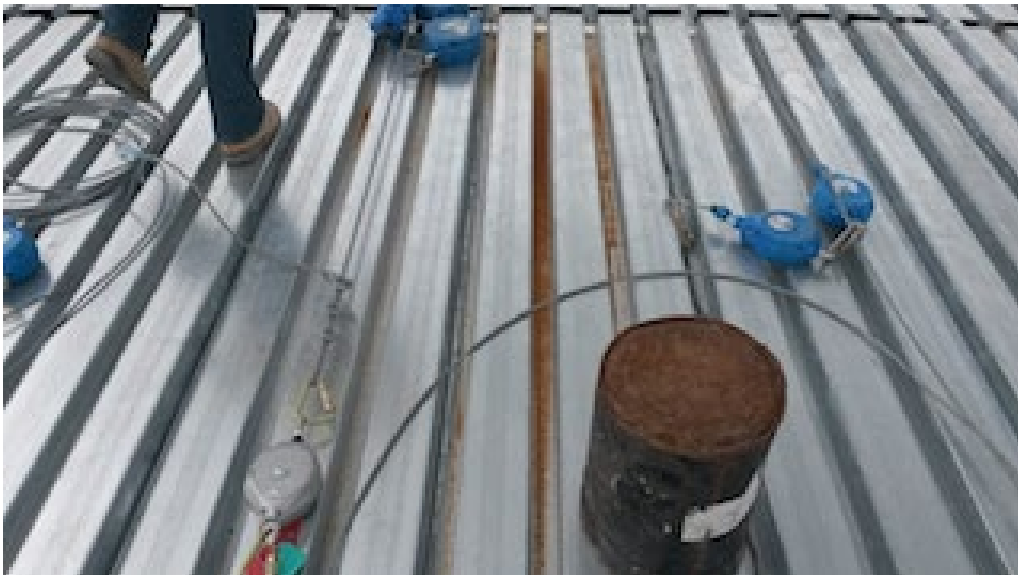
Red rust on the bottom channels of roof decking

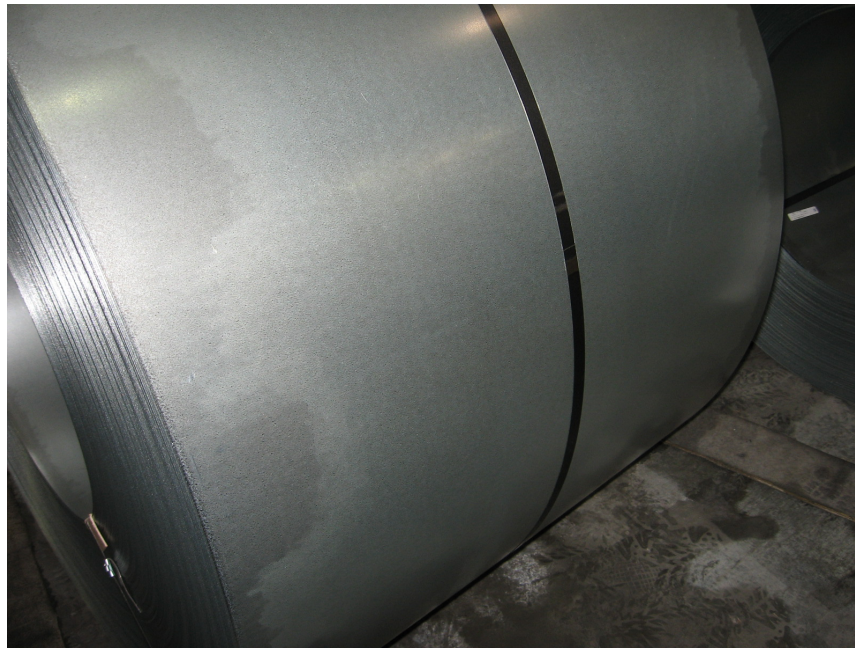
Dark storage stain attributed to condensation on the coil edge “wicking in” between the laps
(September 2016)

The material in the above photo is skin passed galvanized sheet where the zinc surface was smoothed by temper rolling. This stain is not the typical white rust seen due to condensation damage on regular galvanize sheet but has a dark appearance that can be mistaken for staining due to something else, such as chemical treatment or oil. These dark stains have been confirmed to be zinc oxide. A recent study (2020) found that the velocity of Al-based oxide segregation on the surface of temper-rolled HDG was much higher than that on HDG without temper rolling. This was attributed to the surface areas affected by the temper rolls having much more Al-based oxides present due to the Zn crystal grains in the coating being refined by the slight cold reduction, creating an increased number of grain boundaries that can serve as Al diffusion paths. It has

long been known that non-temper rolled galvanized sheet has Al-based oxides present on the surface. The study found that on freshly coated galvanize this level was 2 mg/m², rising to a stable level of about 3 mg/m² after 12 weeks aging at 20°C. The Al oxides were found primarily at the grain boundaries of the zinc. For the temper rolled material, the Al-based oxides measured at about 7 mg/m² after the same aging time, were still on an upward trend, and were also present at locations away from the grain boundaries.

The above may help explain the reason for the dark appearance of storage stain on temper rolled galvanize. It has been observed that the storage stain on 55% Al-Zn alloy-coated sheet (Galvalume®) is seen as black corrosion products when water-damaged. Mild to moderate storage stain damage to Al surfaces is generally black in appearance (Al oxide), whereas it is white on Zn surfaces (Zn oxide). Galvalume coatings are largely composed of Al, whereas galvanize is largely zinc. The migration of Al to the surface of skin passed galvanized sheet to a level of at least twice that of non-temper rolled galvanize, could well be the reason for storage stain on the former product appearing dark. The dark appearance may also be related to the way light reflects off a water-damaged skin passed zinc surface, versus how it reflects off a water-damaged, as-coated zinc surface, which is seen as a white corrosion product. Dark zinc oxide is also seen on zinc surfaces damaged by fretting corrosion (see Section 4).

Whether edge staining is white or dark, both have the characteristic that the stains are a mirror image from the topside to the bottom side surface of the next lap in the coil.

Prevention: Galvanized coils must be prevented from being water damaged by condensation.

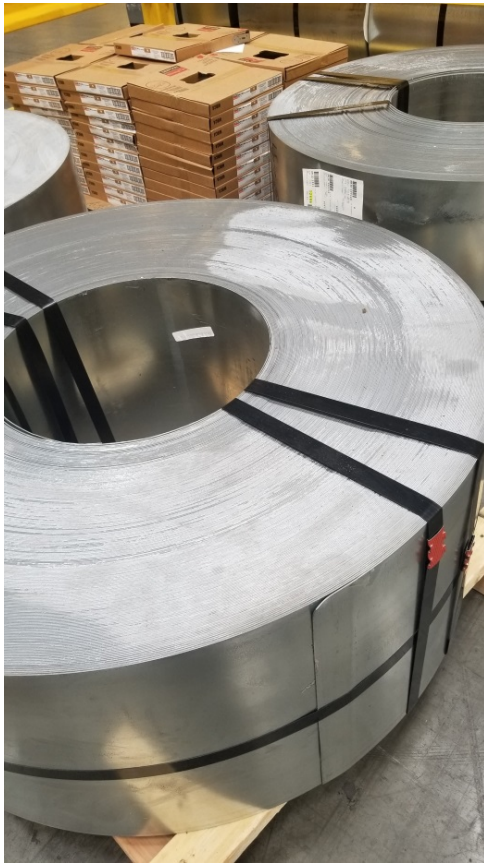
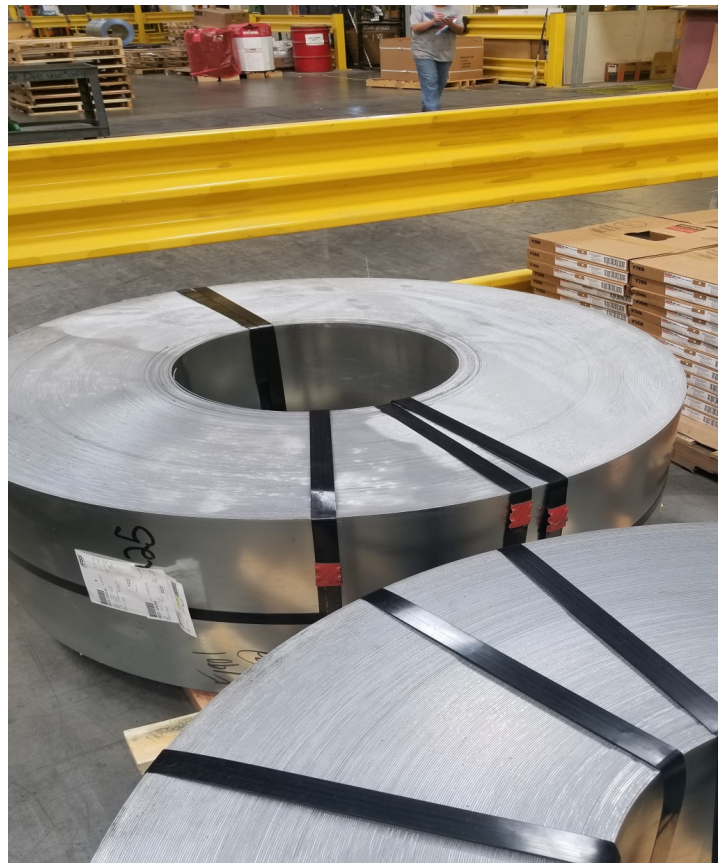
White rust on the edges of slit coils after a 3+ day truck shipment from Stockton, CA to Texas
(October 2017)

Slit coils cut from passivated and oiled master coils in stock since 2014. The slit coils were shipped by truck from Stockton, CA to Texas, taking almost 4 days. How could white rust form on the edges? The likely cause was cooling of the steel, albeit unevenly, during its passage through the mountains. When it came in contact with warm and moist air after the mountains the temperature of the coils, or parts of them, could well have been below the ambient dew point, which would allow moisture to form on the coolest areas of the coil surfaces. The cut edges would have unpassivated zinc exposed, on which white rust can form very quickly. In addition to the coating thickness being exposed on both surfaces of each lap in the coils, some zinc does smear down the cut edge during slitting. The material in this case was successfully processed, as white rust did not have time to form on the flat sheet surfaces.

Prevention: Be aware that moving cold steel into warmer air runs the risk of moisture condensing on the surface.
