Continuous Galvanized Steel Sheet

Corrosion Library

Selected Corrosion Issues Received by the GalvInfo Center as of:

Rev 2 April 2021

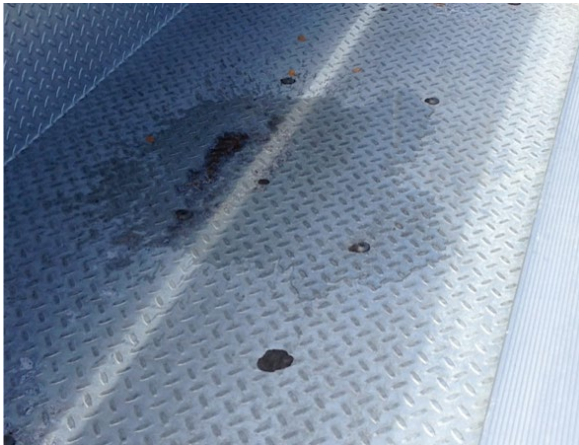
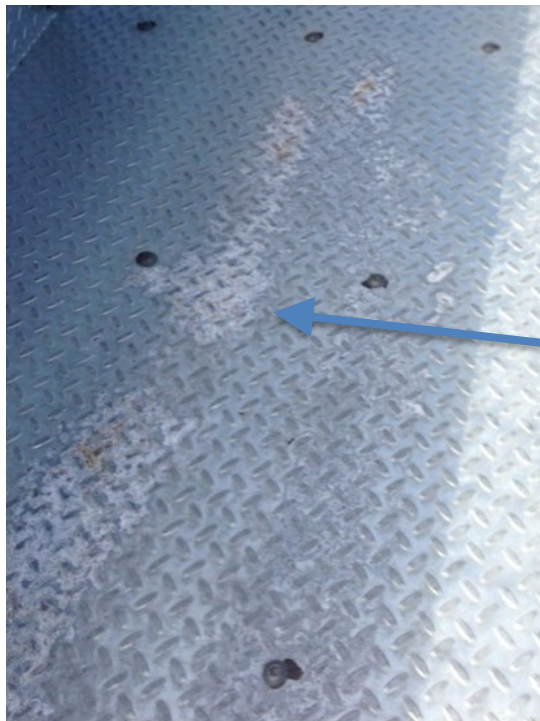
September 2013

Results in inability to form ZnCO_3 leading to rapid zinc consumption

complete draining after wetting events. This interferes with the normal wet/dry cycle times, which prevents the formation of the protective film of ZnCO_3 needed to slow the atmospheric corrosion rate of zinc.

Prevention: Products made from G90 galvanized sheet for outdoor use require that all surfaces exposed to the weather have good drainage and dry relatively quickly after rain events. Allowing water to pool changes the corrosion mechanism such that white ZnOH forms, which can rapidly consume the coating. A G90 coating (~20 microns [0.0008"] thick on each surface) can last 25 to 30 years in a rural environment exposed to normal wet/dry cycles.

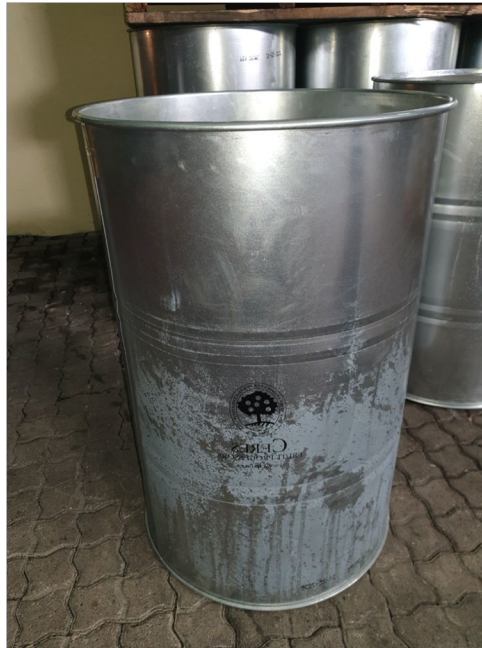
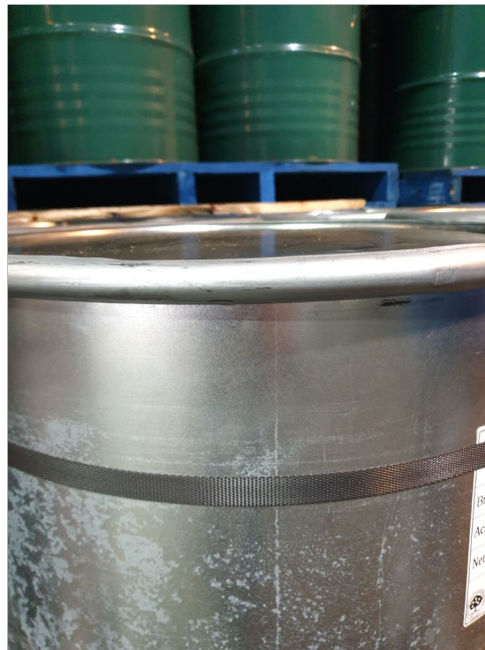
White stains on galvanized drums containing fruit juice (2020)

In South Africa, white stains appeared on galvanized drums containing fruit juice. Splotchy areas of white rust formed on the outside surfaces. The drums were made from Z100 galvanized sheet that was passivated. Double inner plastic bags were inserted inside the drums and then filled with fruit juice. The contents do not come in contact with the metal. After filling, the drums were

sent to a refrigerator at -18 °C before being sent to shipping containers, also kept at -18 °C. Some drums had to be defrosted at ambient temperature for some reason, after which the white stain appeared.

What most likely happened was that condensation formed on the cold areas of the drum surfaces. Note that near the top of the drums there is no stain. That is probably because they were not filled right to the top and the steel temperature in those areas was not below the dew point – like the dry outside upper half of a half-filled glass of cold liquid outside on a hot summer's day. The drum in the first photo appears to have only been half filled.

Why did the passivation not prevent formation of white rust, and why is it so patchy? The process of forming the drums could likely unevenly disturb/remove the passivate from portions of the outside surface, which would allow condensate water (which is aggressive to zinc) to attack any exposed zinc.

Prevention: *The simplest solution is to not allow chilled, filled drums to be stored for any length of time in rooms that are above the dewpoint temperature of the drum contents. Another is to use drums with painted exteriors if the aesthetic look of the white stains is unacceptable.*

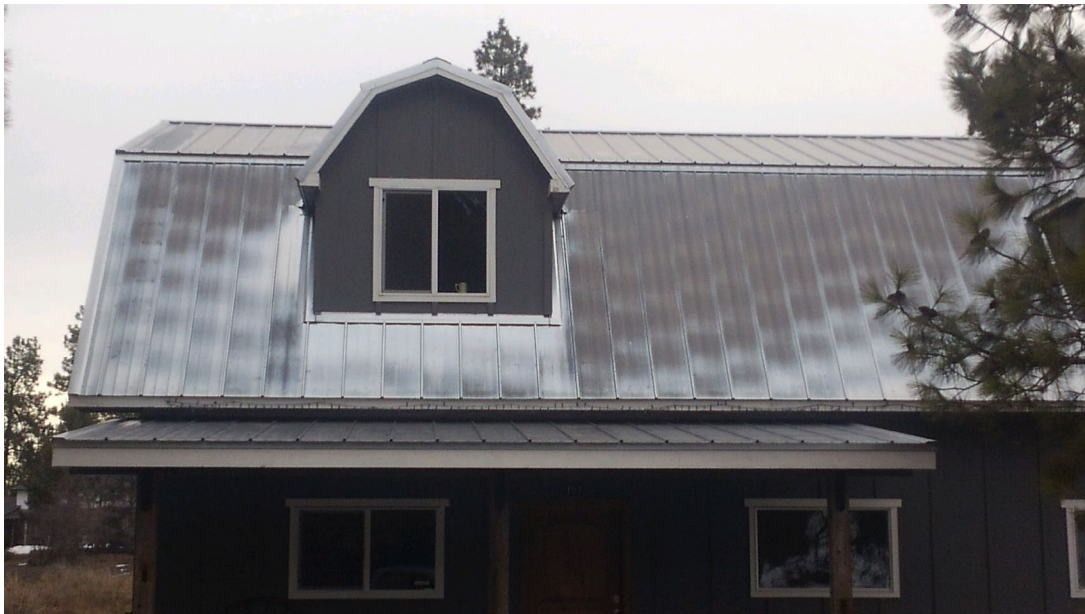
Uneven white rust formation on a G90 roof, 5.5 years old
– west-facing exposure, Spokane, WA area (2019)

White rust formed unevenly on the west-facing roof of a 5.5-year-old house in the state of Washington. The G90 sheet was laid over 7/16" OSB covered by a synthetic underlayment. The white areas formed slowly over time. The author has observed this type of white staining on a roof in Texas where the pure zinc sheet cladding had been laid directly on plywood. The white rust in the above photo is likely the result of dew-sourced water forming repeatedly on the surface when conditions allow, and then not being dried by the sun until later in the day because of its western orientation. One other factor is the variable heat transmission through the roof exemplified by the patterns formed on the surface. The white areas most likely fell repeatedly below the dew point and the dark areas did not.

Prevention: *This problem is best solved at the design stage of building. Ensure that when roofs using galvanized sheet cladding are designed, use proven practices to minimize the chance for condensation to cause staining.*

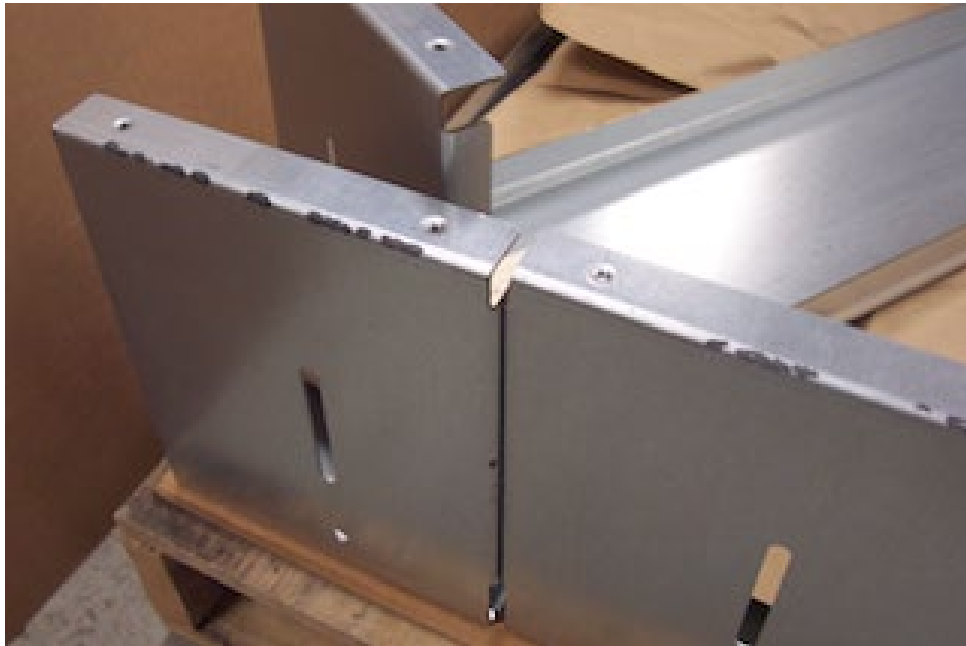
What first appears to be flaking at bends is actually black corrosion on the surface
(August 2011)

A parts manufacturer received a batch that had been formed then stored for 6 months. The photo shows the surface marks present, which when examined closely, look remarkably like a form of fretting corrosion. This happens without moisture present. The marks are most likely due to the zinc surfaces rubbing together during handling and shipping over the 6 months.

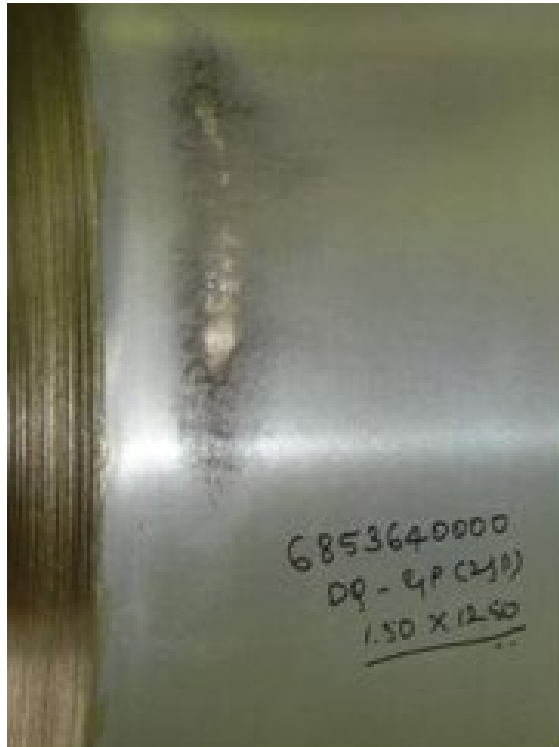
Fretting corrosion (transit abrasion) on a coil of galvanized steel (2010)

In the case of coil form material shown above, fretting marks are located exclusively in the weight-bearing area of contact of the saddle support that cradled the coil(s). The coil had been shipped with its eye horizontal and aligned perpendicular to the direction of movement. *The fretting damage occurs under load and in the presence of repeated relative surface motion, as often induced by vibration.*

Prevention: *In the case of coils, an action that is very effective is redesigning support saddles to reduce concentrated point loading on the bottom of coils. By distributing the weight of the coil over the entire area of the saddle(s), there is less pressure at any one point, resulting in less transit damage.*

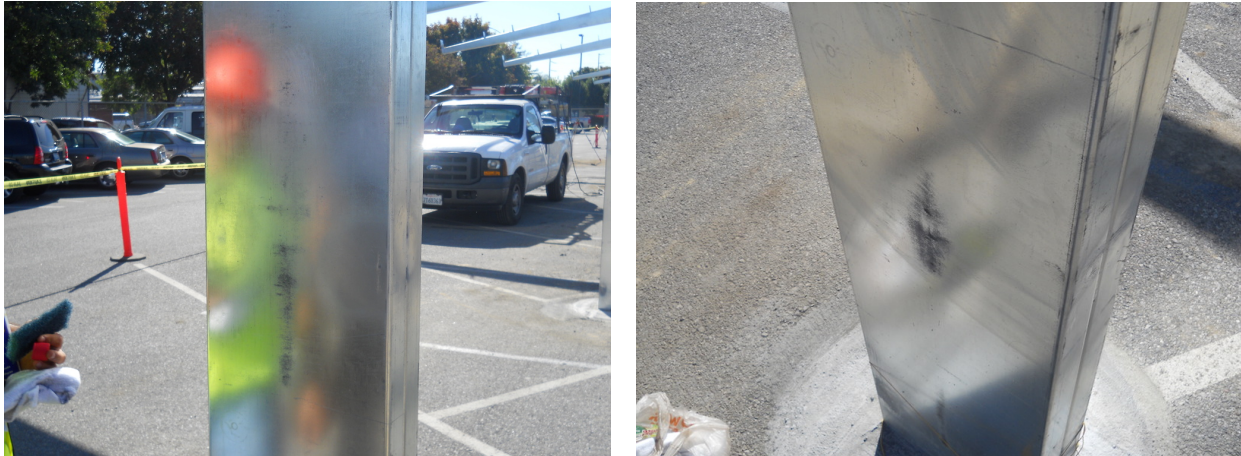
Fretting on Galvanized Poles (February 2012)

The above photos show fretting on galvanized poles in the center of their wide face. *An unsuccessful attempt to clean it is evident in the photo on the right. The black fretted areas most likely occurred during shipping of the poles in bundles with the wide faces in contact with each other.*

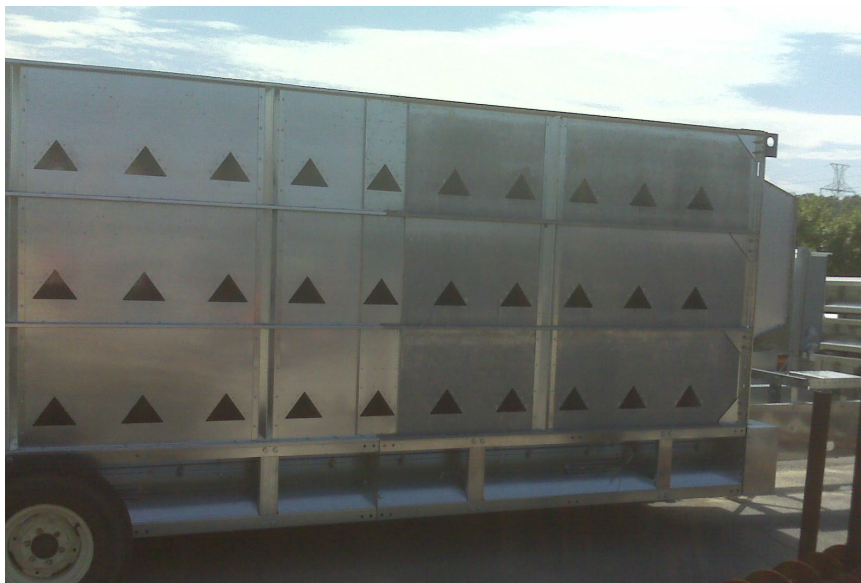
Darkened galvanize (right side) on grain handling equipment (2013)

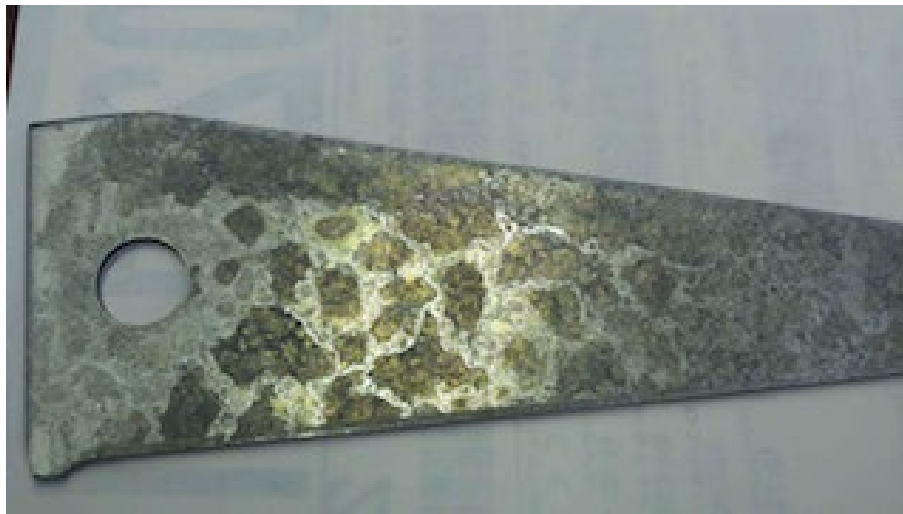
Extreme darkening on G90 (January 2012)

Prevention: Unpassivated galvanize is subject to rapid superficial corrosion by condensate water. It should not be left in a location where dew can form on it.

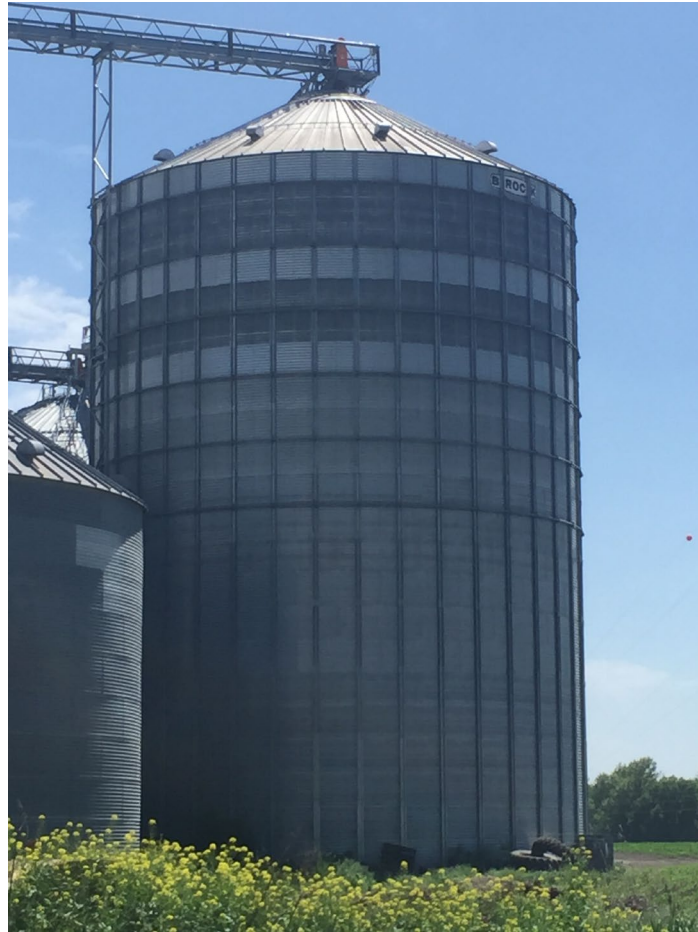
Uneven darkening of galvanized sheet panels on a large grain bin made with material from different lots (2019)

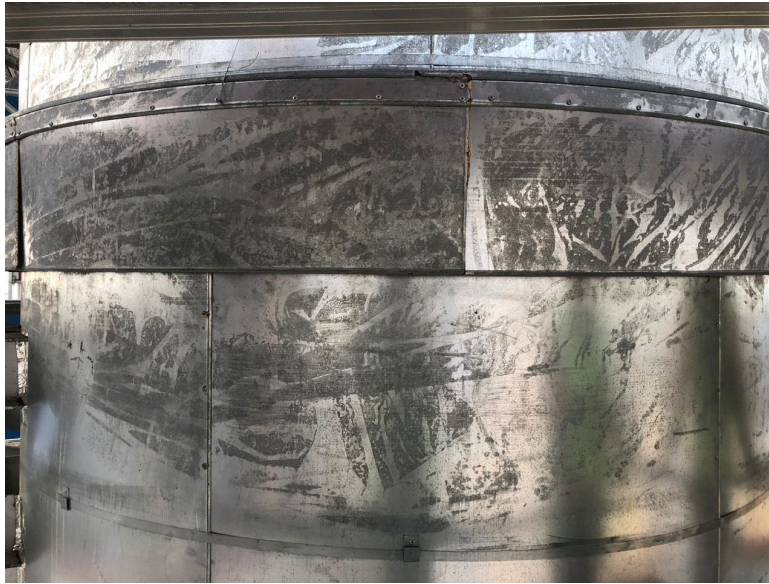
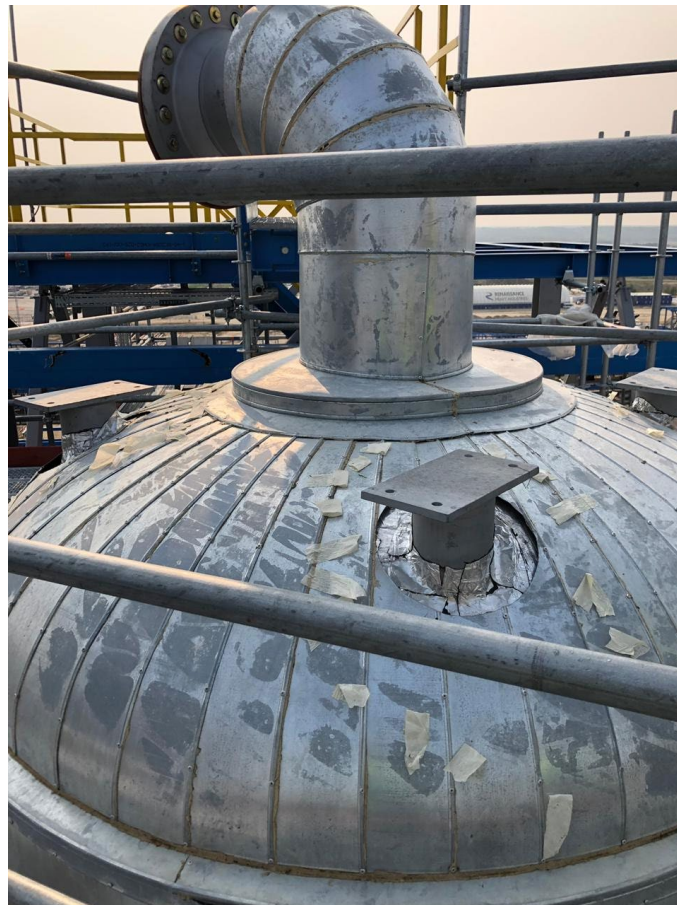
Severe, sudden uneven darkening of galvanized sheet panels on a large refinery installation (2019)

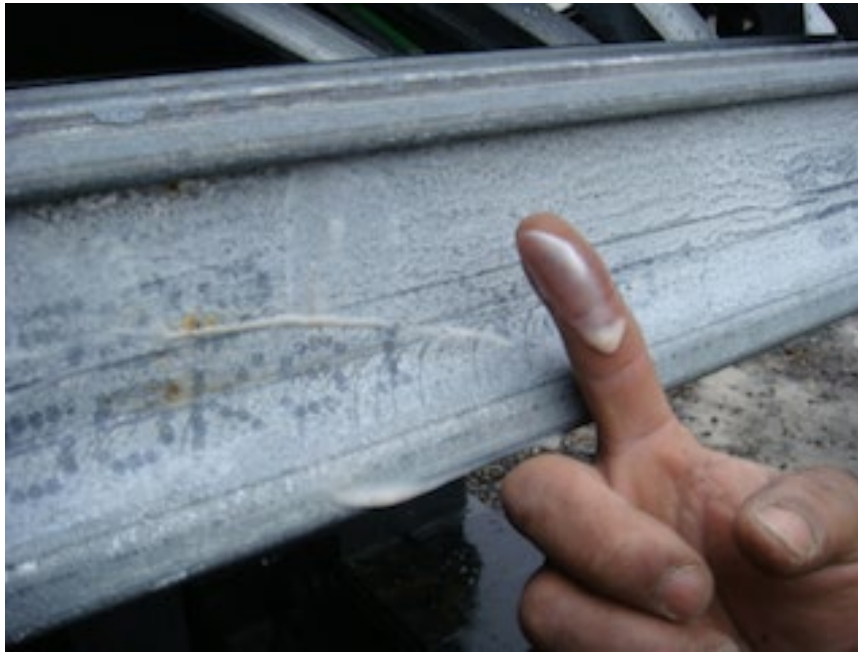
Unknown “foam” on framing after getting wet in the field (January 2008)

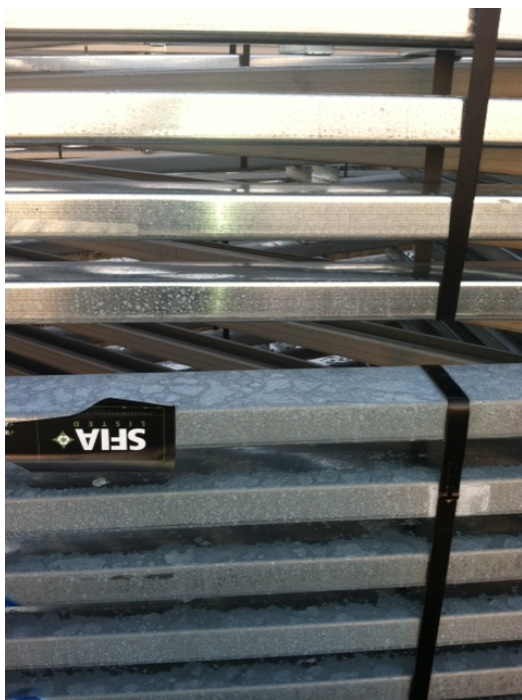
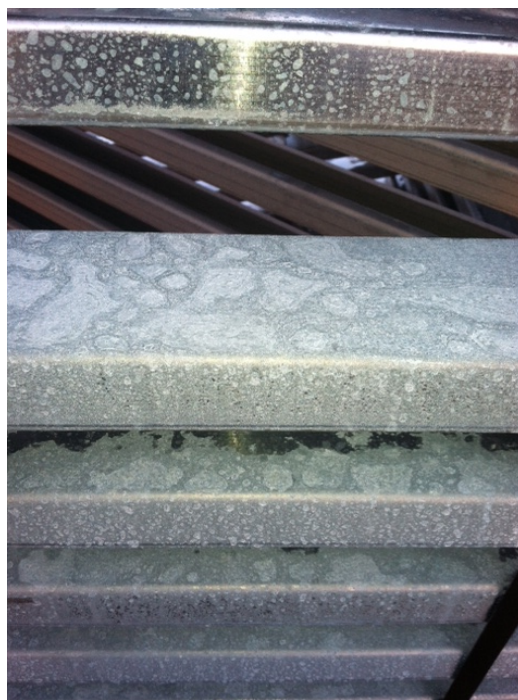
White staining on stacked framing members (December 2013)
