GalvInfoNote

6.3

Successfully Manufacturing Products made with Galvanized Steel Sheet

REV 1.0 DEC 2017

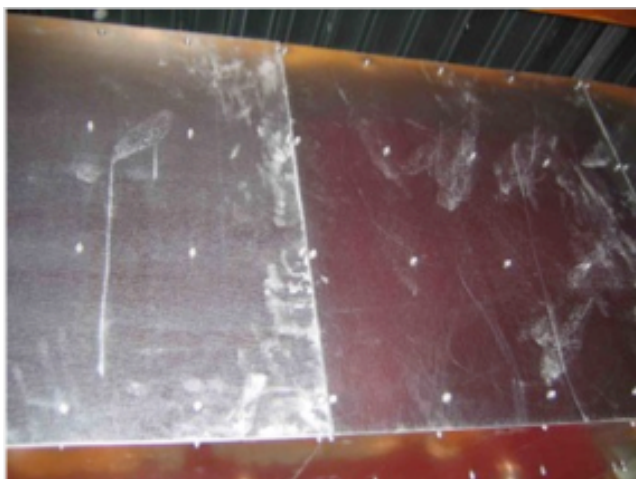
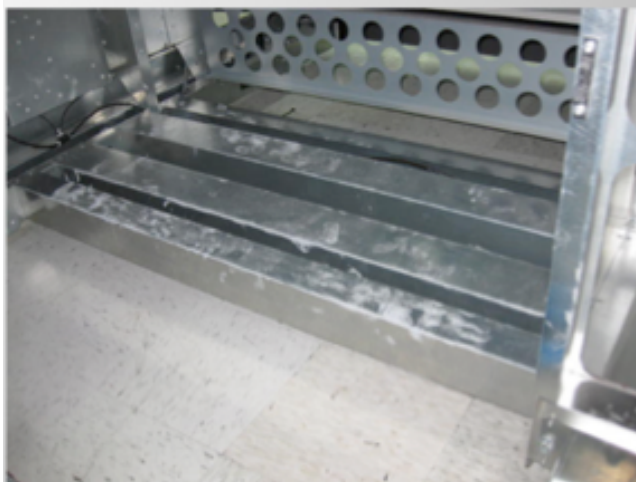
Metallic-coated sheet products are susceptible to surface marking during processing and handling. Galvanized sheet can be permanently affected by white staining due to the perspiration of workers who come in contact with it during the manufacture of products like heating and ventilating ductwork (top left photo). The same problem can happen during manufacture of metal electronic cabinets (bottom left photo). While not harming product durability, the white stains affect its esthetics when intended for an exposed end use. These stains are the result of salt and other compounds in the worker's perspiration reacting with the zinc to permanently mark the surface. Once stained in this manner it is very difficult to remove, and there is no known method of restoring the original metallic lustre. Typical mill passivation treatments do not necessarily offer resistance to this staining.

To provide a product that is resistant to marking, the industry has developed special coatings (typically acrylic-based) for metallic-coated sheet. They are applied over the zinc at the coating line using a roll-coating technique and infrared curing ovens. The coating is clear and consists of a water-soluble acrylic resin with inorganic corrosion inhibitors added. Benefits include resistance to hand and/or foot marking during handling/installation, good resistance to storage stain/transit corrosion, and retention of zinc brightness over a longer time.

To avoid fingerprinting and handling marks, the purchaser can request the galvanized sheet be acrylic treated at the time of production. Most producing mills offer this option at an extra cost. For material that is not acrylic treated, and where the final product must be free of these marks, the best option is to have the workers wear long sleeves and clean, soft cotton gloves when handling the sheets during manufacturing and installation. For more information on this problem, refer to *GalvInfoNote* 2.13.

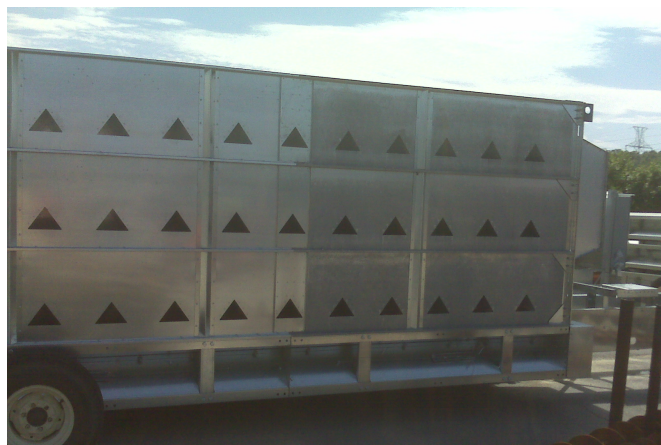
It has even been reported to occur on industrial products after being placed outdoors, as shown in the photo to the left. The material on the right side of the assembly darkened appreciably, compared to that on the left, during the first night outdoors. The galvanize use to make the bright area was mill passivated, while that used to for the dark area was oiled before shipping, *but not passivated*. The significance of outdoor storage is that it can allow dew to condense on the surface of the metal, the significance of which is explained below. Of course, as soon as the dew dries, corrosion ceases, usually leaving the observer wondering what happened in such a short time. Passivated

galvanize will resist such attack and allow the normal, colorless, slow-forming patina to develop. Such a patina can also form on unpassivated zinc if it is protected from aggressive corrosion when freshly exposed.

To prevent this problem from happening, unpassivated galvanize should not be applied to applications where the product will be placed outside. The surface of passivated galvanized sheet is ‘deactivated’ enough that atmospheric reactions are slowed to the point where its normal patina takes at least a few months to develop. Unpassivated zinc has a very active surface and experience has shown that corrosion products can form

quickly and have different appearances. Allowing dew or other condensate to form on unpassivated sheet should be avoided.

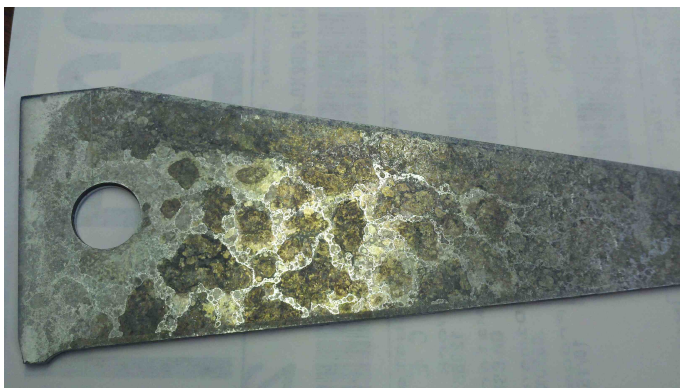
Another example of darkening is shown in the photo to the right. It is an automotive part that was out of specification for some other reason and was later noticed in an outdoor scrap bin. It triggered an inquiry because of concern that it was part of a shipment of defective zinc coating. All galvanized sheet used by the automotive industry is produced unpassivated for weldability and paintability reasons, so this piece was most likely affected by outdoor moisture that rapidly turned the surface partially black. As described above, this staining occurs very quickly by moisture that does not allow the normal oxidation of zinc in the zinc hydroxide, zinc oxide, zinc carbonate sequence that happens over longer periods.

It is most probable that it is a higher amount of sulfate ions that cause the black hue. *“The most important corrosive constituent in the atmosphere is sulfur dioxide, ...and sulfate ions come more from dew than other forms of precipitation.”*² *When heavy mists and dews occur in these atmospheres, they are contaminated with considerable amounts of acidic substances such as sulfur dioxide*³. Darkening is the result of forming these protective basic oxy-carbonate layers and is influenced by the presence of other atmospheric species, including sulfates and chlorides, which influence appearance (darkness). Rainwater is known to have a higher degree of mineralization, which could complex with sulfate ions, thus rendering it less aggressive than dew condensate. Whatever the cause, darkening is a fast acting corrosion process that is very superficial, but creates an unattractive corrosion product. Of course, it is especially disconcerting when it occurs adjacent to bright galvanize.

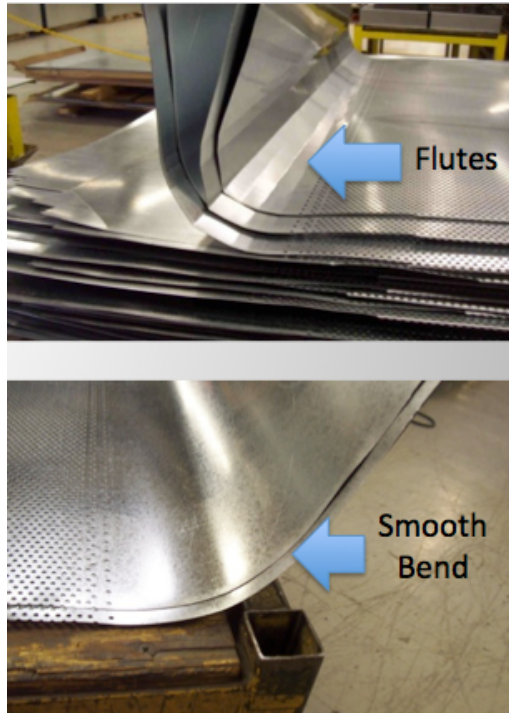
Fluting and stretching strains are marks that appear on the surface of the carbon steel sheet after forming operations. They are caused by discontinuous yielding of the steel substrate and show through the zinc coating. See page 3 of *GalvInfoNote 2.8* for more information on this phenomenon.

The photos to the left show sheets that were subjected to bending using a large radius. The bottom photo shows what is expected to occur when sheets are bent in a controlled manner – the curve is very smooth. When discontinuous yielding is present, the sheet will bend sharply every so often (flute) into a discontinuous curve that is totally unsatisfactory.

To prevent this, and as explained in *GalvInfoNote 2.8*, a small amount of cold work imparted to the sheet by temper rolling (or leveling) suppresses the discontinuous yielding phenomenon. With this behavior having been masked, the steel can be formed with no concern about stretcher strains or fluting.

Temper rolling or leveling are processes that are performed on all galvanized sheet during the coating process (unless intentionally omitted). This ensures that the product can be formed without these problems happening.

Steel sheet that is used within a reasonable time after being received from a steel supplier should not flute or show stretcher strains when bent or stretch-formed. If it does, then it is non-conforming product. What is considered to be a 'reasonable time' differs amongst steel suppliers, but the maximum time allowed for carbon steel sheet is about 6 months. If the time exceeds this then another behavior of carbon steel can come into play, namely *ageing*.

The metallurgy of ageing (which includes strain ageing) is too complex to cover in this note, but the end result is that discontinuous yielding will return after time. To avoid this happening, the steel must be consumed within a reasonable time period. The time to return of discontinuous yielding varies, but is shortened the higher the storage temperature. As covered above, steel producers introduce enough cold work to suppress ageing for up to about 6 months, but this can be shortened if the storage period involves hot summer months. If a user encounters fluting after having had the steel for, say, one year, then suppliers will most likely not honor a claim. To minimize the chance of ageing causing a problem, manufacturers should control inventories to use the oldest steel stock first, hopefully before ageing can create forming issues. See *GalvInfoNote 1.8 Steels Used in Coated Sheet Products*, p. 4 for a more in-depth explanation of ageing.
