3. Corrosion – Mechanisms, Prevention, and Testing	
GalvInfoNote	Fretting Corrosion (Transit Abrasion)
3.5	on Galvanized Sheet
0.0	REV 1.1 DEC 2017

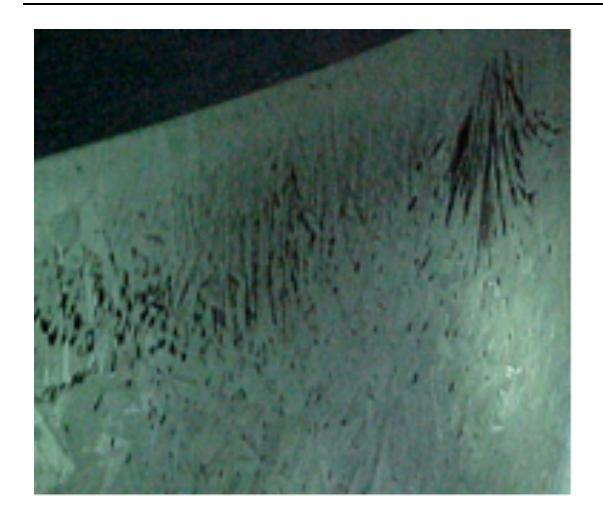
Figures 1 and 2 illustrate the appearance of fretting on galvanized surfaces. In this case the marks are near the edge of the sheet and were reported to have mirror images on the opposite surface.⁷ Figure 2 is a close-up of the mark on the right-hand side of Figure 1.

Figure 1 Fretting near coil edge Figure 2 Close-up of right side of Figure 1 (Courtesy of Shantanu Chakraborty/Rajib Chatterjee – TATA STEEL - India)

All of the above measures are not practical in the case of galvanized sheet, but investigations at one steel supplier¹¹ have indicated that some are effective to varying degrees. An action that is very effective is redesigning support saddles to reduce concentrated point loading on the bottom of coils. By distributing the weight of the coil over the entire area of the saddle(s), there is less pressure at any one point, resulting in less transit damage given that vibration will always be present. A slightly less effective way of accomplishing the same result is to reduce the coil size, but this is perhaps not a desirable option for all situations. With either of these actions, care should be taken to avoid stacking coils during transit, as material on the bottom could become overloaded, even with well-designed saddles under them.

Another option to reduce fretting is to oil the sheet, thereby reducing friction. Oiling has been found not to be effective in all circumstances and has other drawbacks, such as telescoping of coil walls; oil oozing from the walls; and being unacceptable to the customer.

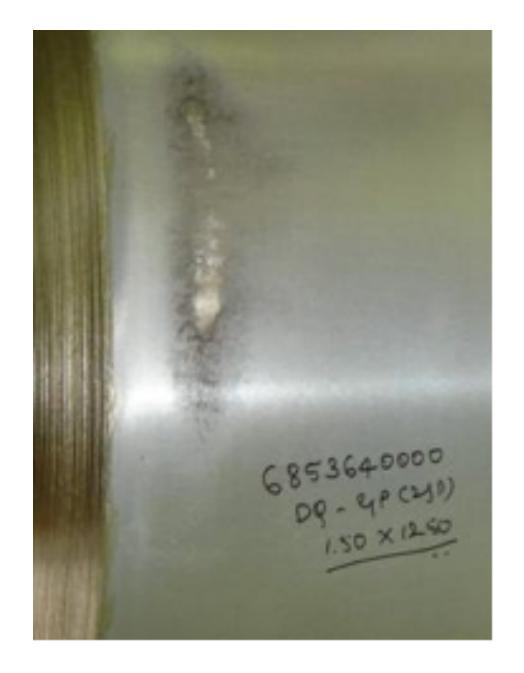
Another observation made about the nature of these marks, in the case of coil-form material shown in Figures 3 and 4, is that they are located exclusively in the weight-bearing area of contact of the saddle support that cradled the coil(s). The coils had been shipped with their eyes horizontal and aligned perpendicular to the direction of movement.

Figure 3 Fretting in area of contact

Figure 4 Fretting in area of contact

The second factor that contributes to transit abrasion is load on the surfaces. The black marks are rarely over the entire surface area of a sheet, but are concentrated in specific regions, that have been noted in some cases, e.g., Figs 3 & 4, to be the point(s) that bear the weight of the entire coil or bundle, and perhaps the additional load of product stacked on top. These bearing points are where the most pressure would result on any surface asperities, and is where fretting would begin if relative motion between surfaces does occur.

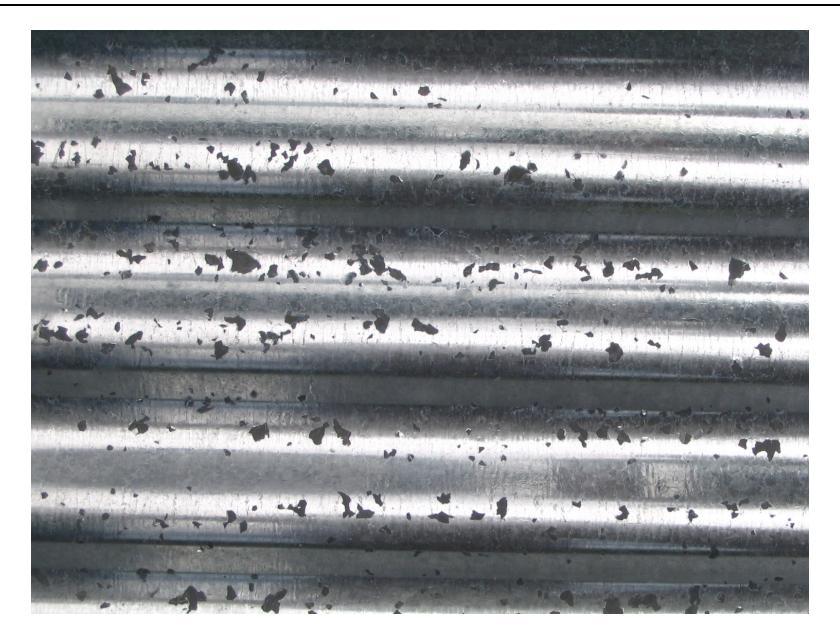
(Courtesy of Shantanu Chakraborty/Rajib Chatterjee – TATA STEEL - India) Figure 5 is fretting on corrugated galvanized sheet that was observed after transport to a jobsite from a rollforming mill.

Figure 5 Transit Abrasion (fretting) on corrugated galvanized sheet

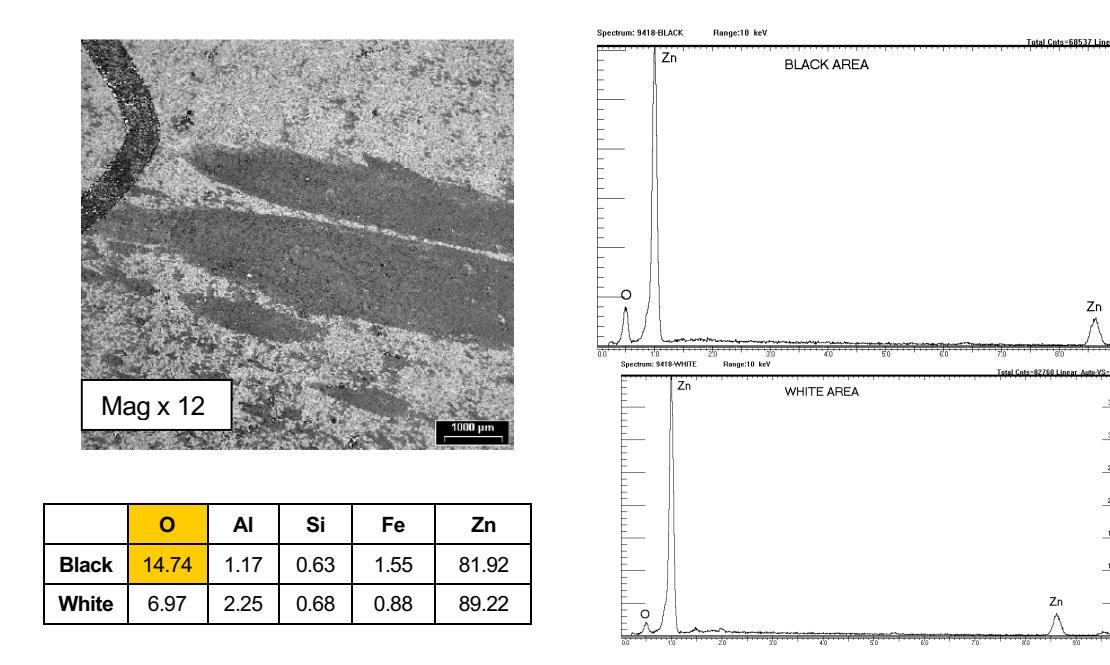
The reason the marks on galvanize are black is believed to come from the nature of the extremely small zinc oxide particles (wear debris) that are the likely result of small amplitude vibration. Zinc oxide that is formed from corrosion of zinc in the atmosphere, or manufactured intentionally for industrial use, is a white powder. Black transit abrasion marks on galvanized surfaces have been shown to be zinc combined with a higher percentage of oxygen than is the case with the metallic zinc on the rest of the surface (see Figure 6)⁸, indicating a different form of zinc oxide. It is theorized that this oxide is black, either because of different

Figure 6 Analysis indicating black area has at least twice the oxygen content of the normal white zinc (Courtesy of Shantanu Chakraborty/Rajib Chatterjee – TATA STEEL - India)
