# Durability of Galvanized Steel Framing in Residential Buildings

Summary of a ten year report produced by NAHB Research Center, a subsidiary of the National Association of Home Builders (NAHB) in the US and sponsored by International Zinc Association

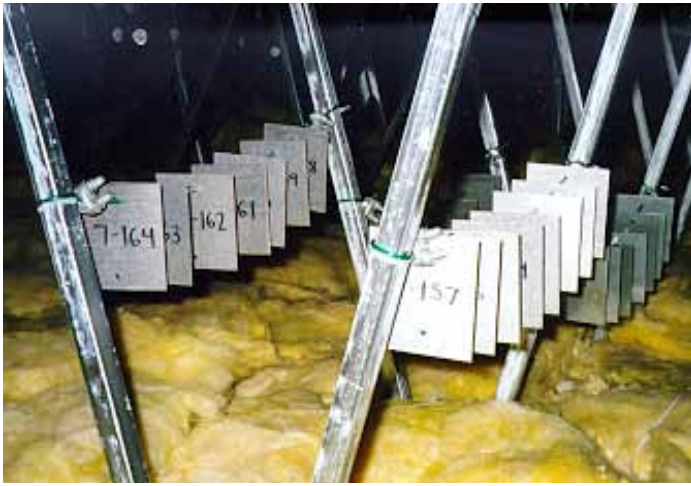
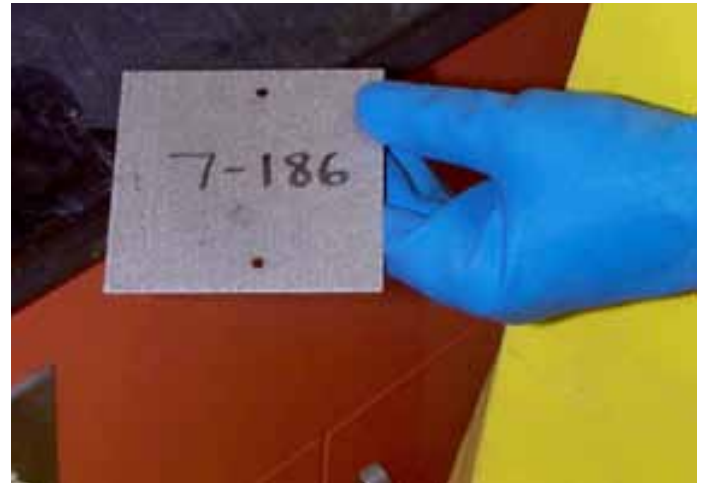
Figure 1 – Plate Samples

of the specimen's area, and thus a more accurate measure of coating corrosion rates calculated from mass reduction of the samples after exposure (Figure 1). The C-section samples were installed to investigate corrosion performance at the edges and bends of a stud. Both the plate and stud samples had both sides and all edges exposed. The coating thickness specifications and measured coating weights of the samples are listed in Table 2. Coating Thickness (column 5) is the calculated coating thickness based on the measured coating mass in column 4. Coating tests performed per ASTM A90/A90M<sup>1</sup> determined that actual coating masses (column 4) were all above the minimum specification requirements. Samples were installed to allow for analysis after one, three, five, seven, and ten years of exposure. An overview of where samples were installed in the four sites is provided in Table 3.

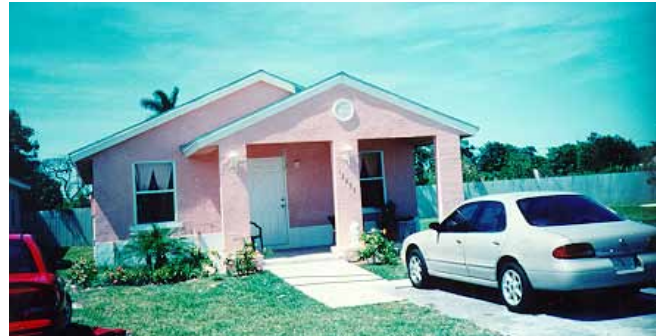
Figure 2 - Miami, Florida Corrosion Site

The Miami site (Figure 2) was in a Habitat for Humanity Development in southwest Miami, where 16 of the 90 homes were framed with steel systems. The site was a single-story steel framed structure with a slab on grade foundation. It had plywood sheathing with a stucco exterior finish. The wall interior was 5/8 in. (16 mm) painted drywall. The attic was kraft faced (facing the drywall) R-30 fiberglass batt insulation, while the walls have either R-11 or R-13 batts. The walls were 6 in. (152 mm) wide. The attic was vented with soffit vents [19 vents total, each is 22 in. x 4 in. (56 cm x 20.5 cm)]. No ridge vents were present, and one small gable end vent was visible in the front of the house.

The house was air-conditioned and the type of environment could be classified as humid/inland. Although the site was in southern Florida it was several miles from any large water body. There was no shading of the house on the western exposure, where the wall cavity colonies were located.

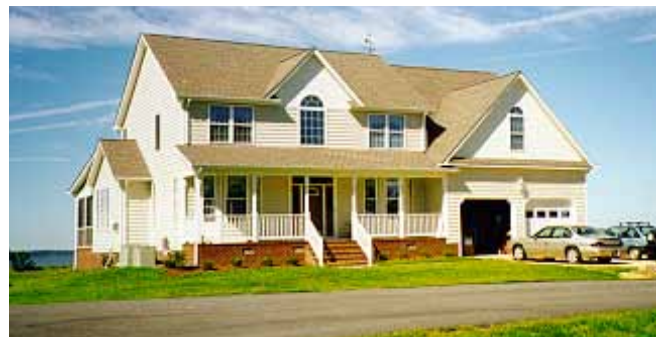
Figure 4 - Leonardtown, Maryland, Site on lower Potomac River

The Leonardtown, Maryland, house (Figure 4) was on the lower Potomac River before it empties into the Chesapeake Bay. The two-story home was roughly 75 feet (23 m) from the river, with strong winds often blowing spray towards the house from the brackish river water. The walls were framed with 0.043 in. (1.1 mm) thick steel C-section studs, while steel trusses were used for the roof framing. Steel floor joists were used in the crawlspace along with R-19 fiberglass batts. A layer of poly was installed on the crawlspace floor. The attic was insulated with 11 in. (28 cm) of blown cellulose and vented with a ridge vent and soffit vents. The walls consisted of 5/8 in. (16 mm) drywall, wet-blown cellulose (R-13), OSB sheathing, 1 in. (25 mm) of non-foil faced foam cladding (R-5), an air infiltration barrier, and vinyl siding. All bathrooms were vented directly to the outside. The foundation was vented with perimeter vents in the block wall.

Specimens were installed in the attic, an exterior wall, the crawl space, and under the outdoor deck. The crawlspace contained a set of suspended samples fully exposed to the ambient crawlspace environment, including bare (stripped) stud-type specimens. The bare samples displayed extensive corrosion after just two months of exposure, indicating the aggressive environment in the crawlspace (see Figure 5). Specimens were also installed under an outdoor deck, which represented

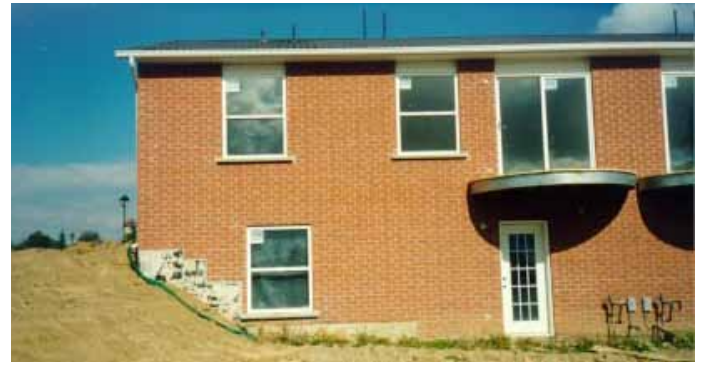
Figure 6 - Hamilton, Ontario Test Site (Rear View)

The Hamilton, Ontario, house (Figures 6 and 7) was a 2-storey townhouse block built on a concrete floor slab in a retirement community. It was the end unit, with a walkout on the ground floor. Three of the four walls were concrete block, with the fourth wall (east facing) being steel-framed. The framed walls were designed as follows: interior wall covering was 5/8 in. (15 mm) drywall, behind which a poly vapor barrier was installed. The walls were insulated with R-13 fiberglass batts. Beyond the framing was 1-1/4 in. (32 mm) of foam sheathing (R-7). Outside of the foam sheathing was a 1 in. (25.4 mm) air gap, with a brick veneer finish beyond this.

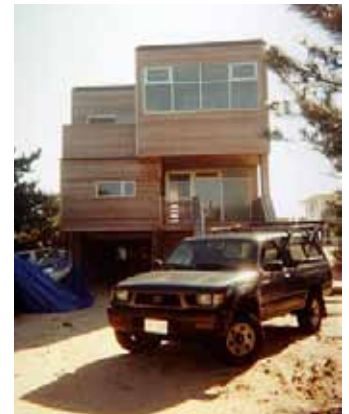
Figure 8 - New Jersey Site

The Long Beach Island, New Jersey site (Figure 8) was the last addition to the research study with specimens being installed in 1998. The site was a beachfront house on the New Jersey shore, and was separated from the ocean by a low-lying dune roughly 1/4 mile (400 m) wide. The house was originally a one-story structure, and was remodeled to include a new second floor and roof that were both framed with cold-formed steel (Figure 9). The house was occupied primarily during the summer season, and was left vacant during the winter.

Three sample colonies were established in the New Jersey site. The first was a full set of stud and plate samples located between the joists that supported the first story. This location should carry some risk of corrosive conditions because it was not immune to infiltration air and outdoor conditions. The second colony was located on a cantilevered deck that hung off the second story of the home and faced the beach (Figure 9). The joist bays under the deck were vented, which presented an opportunity for ocean breezes to deposit salt
